Democrat 1948 console

By Graham Parslow

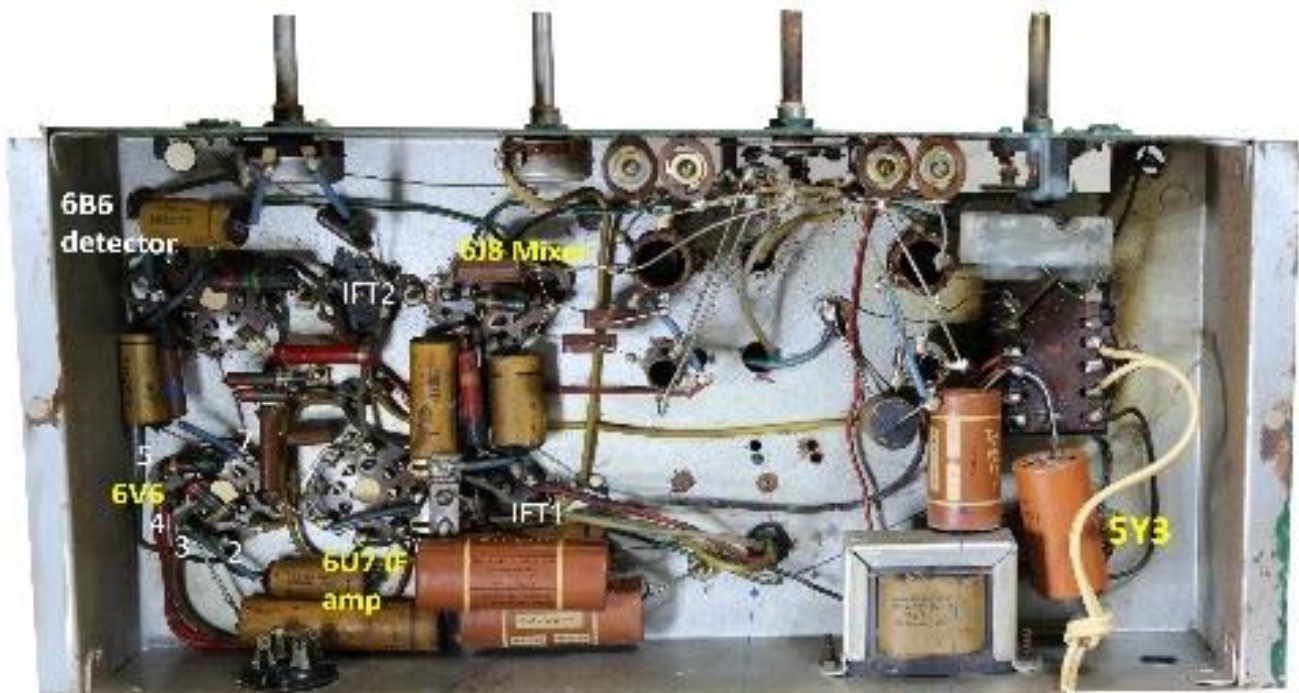
6V6 pin 8
cathode earthed

6U7 shielded

Magic eye

Back-bias bypass

The under chassis photo included here shows the radio with the original transformer in place. An interesting set of connections that can be seen here is at the mains transformer centre tap of the secondary windings. There is

the negative end of an 8μF 525VW electrolytic and the negative end of a 25μF 40VW electrolytic. The explanation is that the low voltage electrolytic is an AC bypass to the 250Ω plus 75Ω back-bias resistors connected to earth (see the circuit diagram). This is the only radio I have encountered with such a component. It would not function in the same way as a cathode-resistor bypass capacitor shunting audio frequencies, so it must be an additional ripple (hum) filter.

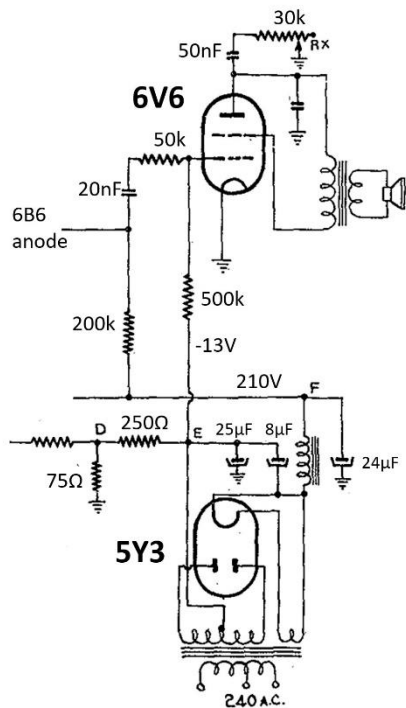
The first assessment was a check of the transformer with no valves in place. The result was puzzling. What was certain was that the original transformer was headed for the bin. The 5V and 6.3V windings were fine, but the HT secondaries were producing 140V at both sides of the centre tap (far too low). The

transformer was also consuming 120W although there was no arcing or dreaded smoke. I have no explanation for this because I would expect shorted turns to affect one side of the secondary HT windings relative to the centre tap (not an even 140V each side as measured). By good luck I had a suitable replacement transformer on my salvage shelf.

The replacement transformer was larger, mounted vertically and required some metal work to install. The bonus was that the replacement was a better quality unit than the one it replaced. The original had the transformer wires terminated on a phenolic board immediately under the transformer body. This board was left in place and the flying leads from the replacement transformer were soldered to the appropriate lugs on the board.

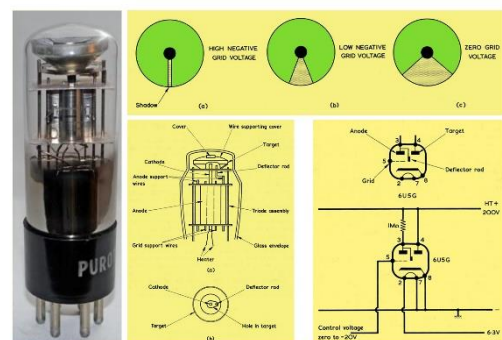
the diode. However, one close transmitter generated minus 23.8V. If you look at the diagram showing the function of the 6U5 you will see a 1M resistor shown in series with the deflector anode. For this radio I found that a 330kΩ resistor gave optimal operation.

The 6U5 in this radio was the common 6-pin version, but the diagram included here features the octal base version that is electrically identical. With reference to the octal version when the grid at pin 5 = 0V the anode passes current and the voltage at the anode drops due to the 330K resistor (1M in the diagram). $V = RI$ by Ohm's Law. When a negative voltage is applied to the grid, conduction (current) decreases and the anode rises toward line HT voltage. This causes the deflector to close the eye and indicate that a station is tuned.

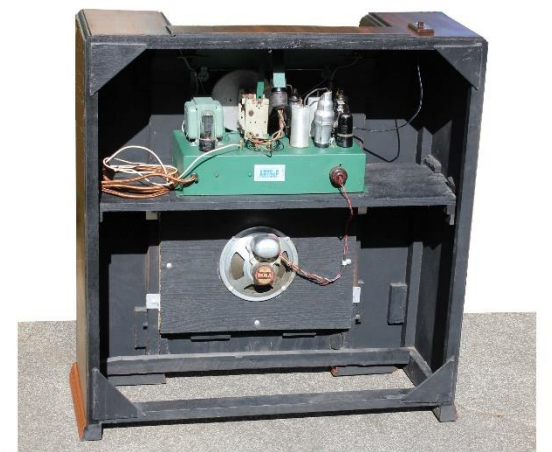
The frame of the 8 inch Rola speaker was severely corroded. However, that was not the major reason that led to it being binned. The cone was poling, that is the voice coil was rubbing against the coil gap. Because no 8-inch was in my stock I replaced it with a 6-inch

Rola speaker complete with transformer from my salvage shelf. A new baffle board was cut to size and new speaker grille cloth installed at the front of the baffle.
