Pye 9MSW 1955

By Graham Parslow

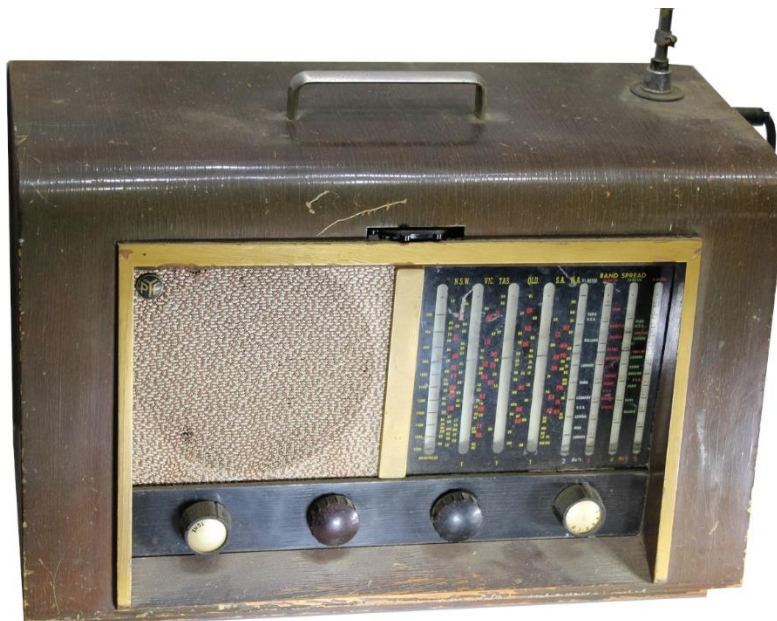
From the front view three non-original fittings stood out. There was a convenient carry handle (kitchen drawer type), a car radio antenna and two wrong knobs. However, the

greatest unexpected additions were at the side where a power ON-OFF switch was added as well as a socket for an extension speaker with a switch to connect it. Rather than snip the coax plug off the antenna cable a car radio socket was added to the side. Various holes with no obvious function added extra ventilation.

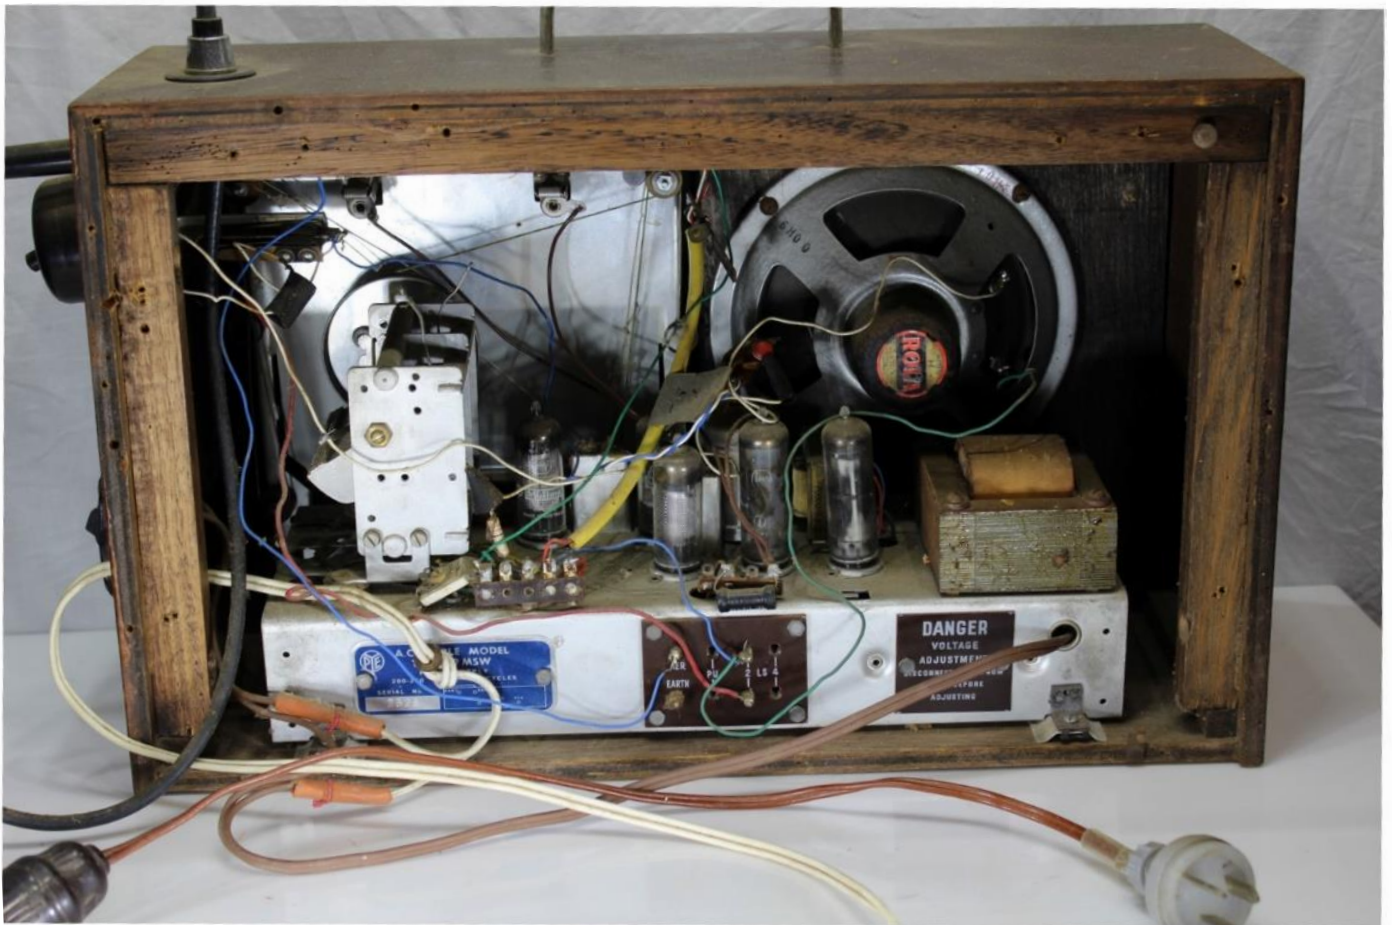
The back was a riot of wires crossing back and forth as each new inspiration for an addition or repair had come to the

cowboy. I was delighted; this was a worthy challenge.

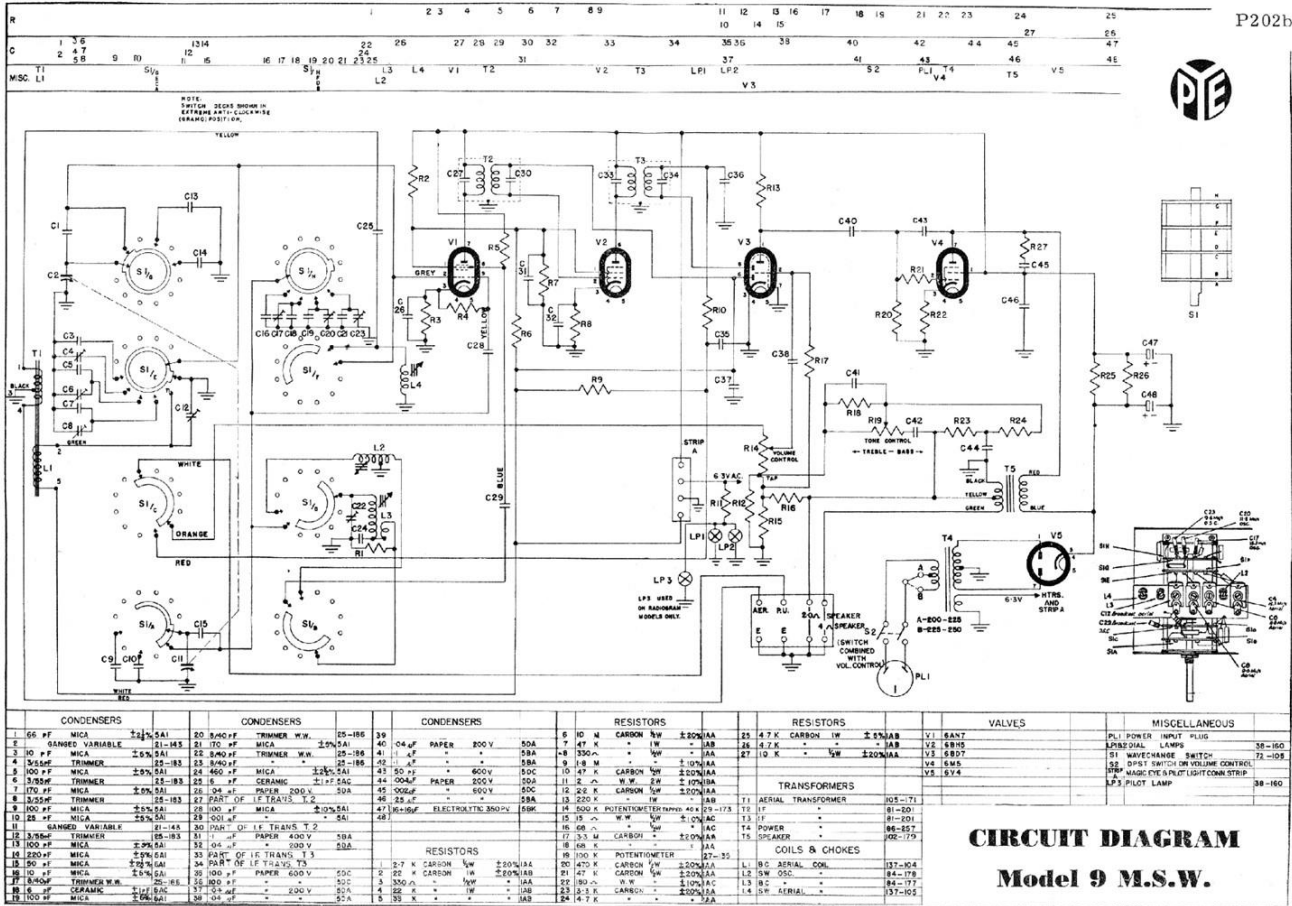
Several things looked suspicious under the chassis. As found, the tone control circuitry made no sense. I realised that the tone control pot was a new replacement – very

enterprising of the cowboy to replace it. However, the cowboy apparently omitted to take a detailed record of what connected to what. The result made no sense and it was sheer luck that those random connections did no more than render the tone control useless. The tone control in this radio is sophisticated for a single knob because it uses selective frequency cuts driven by negative feedback from the speaker output. It took some time to undo and redo the wiring to match the circuit diagram. The circuit and supplementary information for this Pye radio can be found in the HRSA compilation of circuits by Philip Leahy in book 5 (contact Stan Synders at the HRSA valve bank to purchase books in this series).
