1950 Stromberg Carlson model 5A39

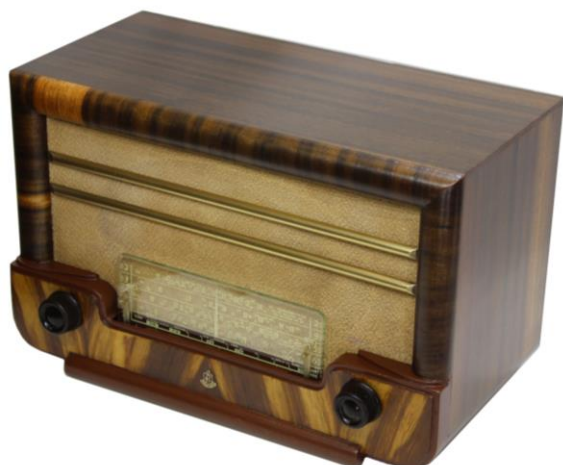
As received it looked damaged and dirty and all valves had been removed. The wooden top had relatively deep fissures in the surface due to the way the wood and shellac had reacted to heat from the valves over many years. There were a number of scratches and blemishes and the good news is that they turned out to be more superficial than they looked. The Stromberg-Carlson badge was nearly black from grime and oxidation. Fortunately the two “missing” knobs were in a separate plastic bag.

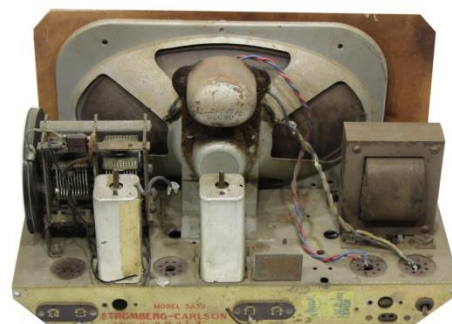
The chassis was loose and easily slipped out. The speaker, made by Stromberg Carlson, is a relative whopper and the cone measured in at 6 x 10 inches. The first striking feature, after the missing valves, was two free-hanging sets of twisted wires from the speaker. The speaker was also free standing without screws securing it to the chassis.

Dangling wires are always a challenge to sleuth out what could have been in the mind of the person who made them dangle. The red and blue pair were the speaker transformer primary connections and the decomposed rubber pair went to the secondary (i.e. the speaker coil). One possibility is that the loose speaker was explained by failure of either or both the transformer and speaker. A quick check with a good old analogue resistance meter showed a healthy transformer and an encouraging crackle from the speaker. Another explanation is that someone wanted to use this speaker separate from the radio so they disconnected all tethering leads and the chassis securing screws. The two wires that went to the speaker coil are most likely original and connected to achieve negative feedback by

earthing one side of the speaker and connecting the other side to the cathode of the 6SQ7 preamplifier. In this case I was able to ask Bill if he knew the answer. He replied that the answer was lost in the mists of time.

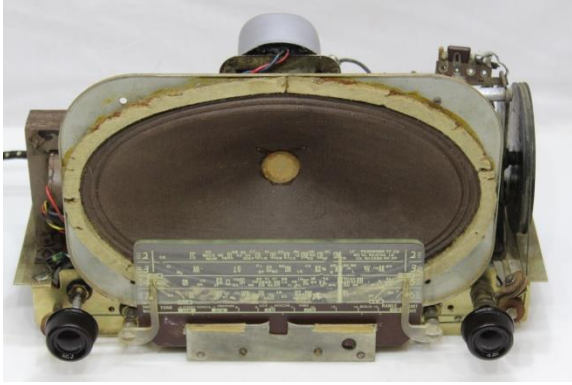
The circuit diagram of the model 5A39 shows that the radio is a reasonably conventional 5-valve superhet. I looked in my valve bin and could only muster a spare 6V6 and 5Y3. Accordingly I contacted Stan Snyder to acquire the other three valves through the HRSA valve Bank.

Restoring the chassis began with a good wash with turpentine and a blow with compressed air. Removing the grime revealed a transformer-like footprint on the top with two holes at either end. A look under the chassis revealed no choke (L8 in the circuit diagram).

I only had one choke in my spares bin that had the right hole spacing so it was duly installed. An oddity of this circuit is a $0.5\mu\text{F}$ capacitor across the choke and I was intrigued by the reasoning for this. Why add a component that will pass ripple across a component intended to block ripple? I have no idea. Also this creates an L-C circuit that could potentially oscillate to no good end. The $0.5\mu\text{F}$ paper capacitor had a bad look to it with cracked ends, but it tested fine. Even so it was deleted to leave a conventional HT filtering arrangement. The

two HT filter electrolytics were replaced as a matter of routine. The second HT filter electrolytic shared a common case with the 25 μ F bypass capacitor for the 6V6 cathode, so a separate discreet bypass electrolytic was installed. The circuit diagram shows the twinned electrolytics as C24 & C25. The speaker transformer primary was reconnected to pins 3 and 4 of the 6V6. These pins also connect to a 2-pin socket at the back of the chassis, presumably to connect to an extension speaker using a line transformer.

At last the valves were all together and plugged in. In a fairy tale the radio would come to instant life and everyone would live happily ever after. In reality this one first alternated between silence, humming and motor-boating. In the end C7, C13 C19, C23, C24, C25, L8, R3 and R4 were replaced because they were either faulty, suspicious or missing. The radio was sensitive to vibration with the first EBF35 installed. It was a valve fault rather than a bad socket and a second EBF35 valve was needed for stable operation. Finally the good quality of sound was compensation for the effort.
