1951 Stromberg Carlson model 51A12

By Graham Parslow

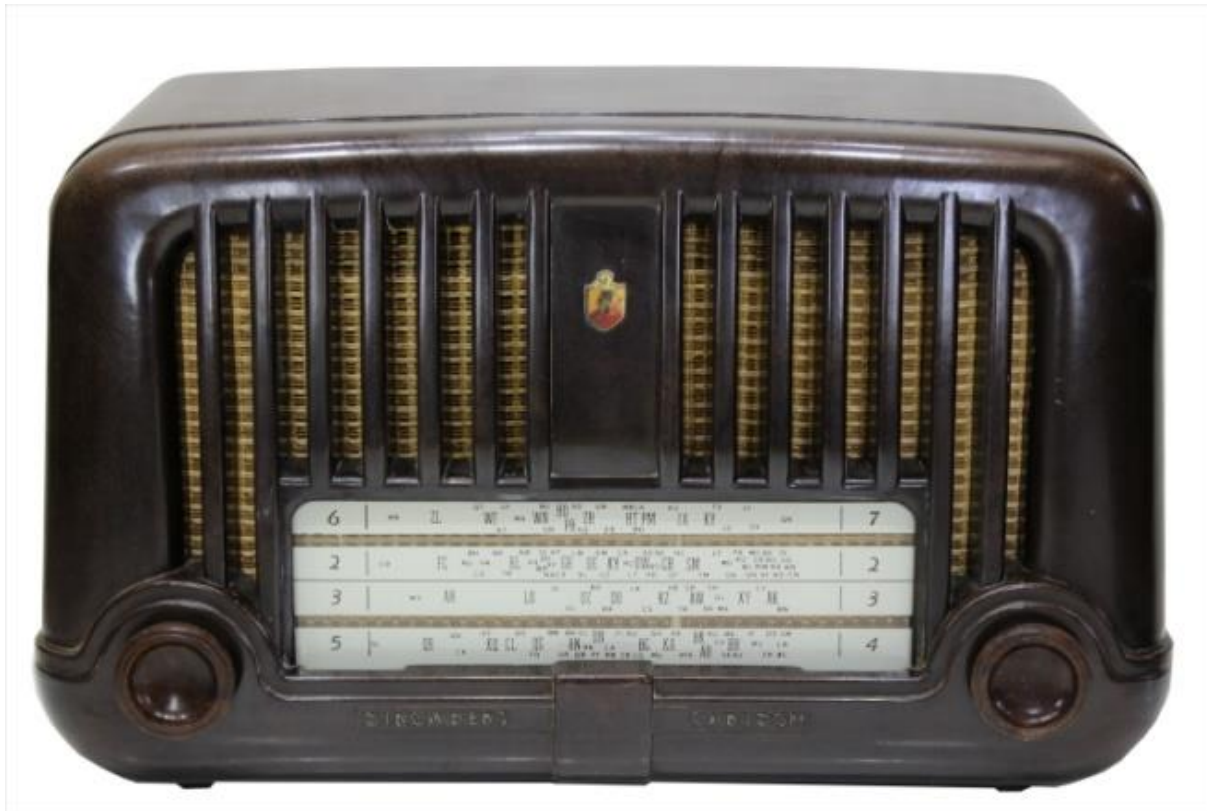
two radios (and a number of other Stromberg Carlson radios) share the same metal work for the chassis with mostly identical punch holes. This explains the in-fill of an octal punch hole on the 51A12 to accommodate the miniature 6BD7 valve.

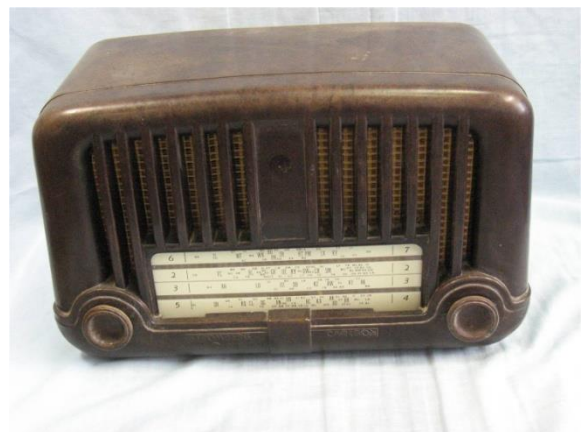
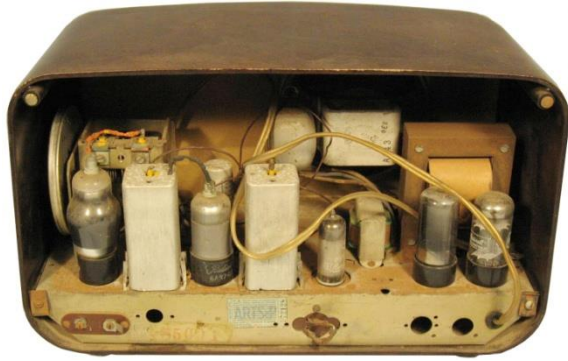
This radio was purchased through eBay in 2008 and serendipitously I was able to collect it in Adelaide as part of other travel. The sellers only knew that it had been lying around for some time and that it did not work. The initial appearance was a bit dusty with faded Bakelite.

I polished the cabinet, created a badge and changed the mains cable to a 3 core earthed lead. The wiring to the RF valve grids had degraded and was replaced. The dial cord was broken and my wife provided some strong cotton sewing thread to restring the radio. I now have proper dial cord, but the cotton thread continues to be serviceable so it has remained in place.

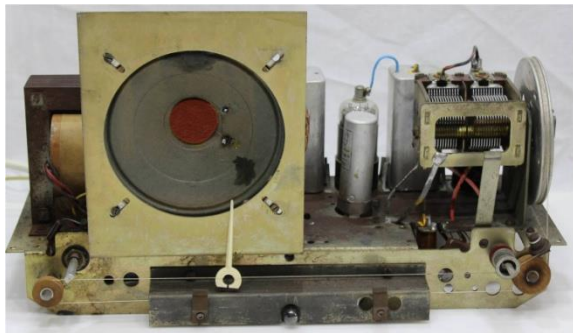
The front picture of the speaker shows two dark glue patches. The lower one is where I used PVA glue to repair a tear. The patch at the top is where a previous repairer had done likewise, but also padded the rear of the cone with a wad of cotton wool. That wad of cotton wool is now a permanent feature of the speaker because it is glued solid and the cone would be ripped if removed. It has little effect at low volume, although I suspect that it affects fidelity at higher volume. It is hard to tell precisely what factors degrade the quality at high volume.

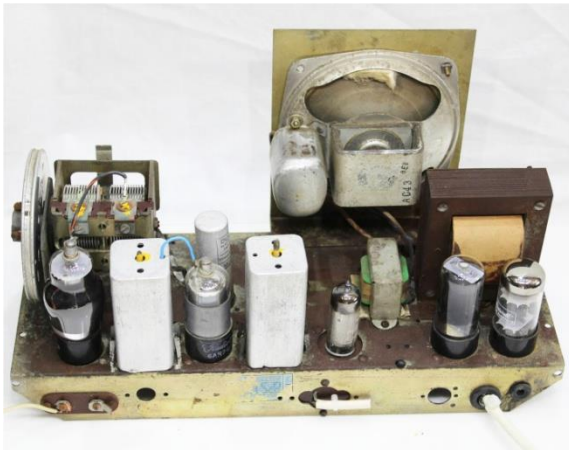
The one year earlier 1950 model 5A39 used ECH35, EBF35, 6SQ7, 6V6 and 5Y3 valves. The circuit of the 51A12 reveals a slight modernisation of the valve line-up for 1951. The rectifier is now an indirectly heated 6X5 valve, supplanting the use of a 5Y3 directly heated rectifier. Accordingly only one low voltage winding (6.3V) needs to be provided by the mains transformer. The HT circuit produced a measured anode voltage at the 6V6 output valve of 171V and the screen had 183V relative to chassis. The grid bias of -8.9V for the 6V6 is provided by passing the rectified HT to earth via a 200Ω resistor and directly connecting the cathode to earth. This saves the cost of a cathode bypass electrolytic capacitor.

Tying the two diode pins to earth for the 6BD7 appears to be an odd feature of the circuit, but those rectifiers are superfluous because the 6BD7 is used only as an audio preamplifier. The 6AR7 has the diodes used for rectification and AGC.
