THE 1946 HEALING MODEL 401E KITCHEN RADIO

By GRAHAM PARSLAW

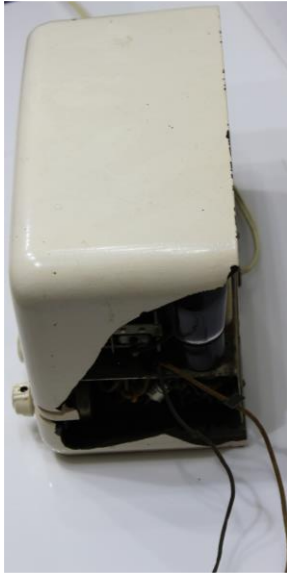
reluctant to go beyond \$150 on eBay where this model has shown a consistently high valuation. The “bargain” price is arguable because of the very poor presentation of the radio as acquired. The case was a conventional dark brown Bakelite that was factory-painted cream. It seems that the factory finish had become chipped to show the dark base so a previous owner took some cream enamel paint and applied it liberally with a paint brush. Every corner crevice in the speaker grille was filled with paint and the knobs hardly had the creases evident due to the thickness of paint. The finish overall was rough, but good enough for this “rejuvenated” radio to serve a few more years in the kitchen. It was most likely in a kitchen that the radio acquired a layer of tar-like stain over the components from a combination of cooking vapours and cigarette smoke. The radio must have had a long service life because it had been re-capped with 60s vintage capacitors. At some stage it was dropped with the dramatic effect of breaking off most of the right hand side and less evidently fracturing the internal speaker mounts and a chassis-locating spigot. The radio was jokingly sold as a model with extra ventilation.

The great challenge was to restore the right hand side of the case, so this was where the restoration started. First came some hours spent with paint stripper and a scraper. This initially peeled back the hand-painted layer and left the factory cream coat beneath. The factory layer subsequently succumbed to the paint stripper. Apart from the right hand side, the stripped Bakelite case was seen to be intact.

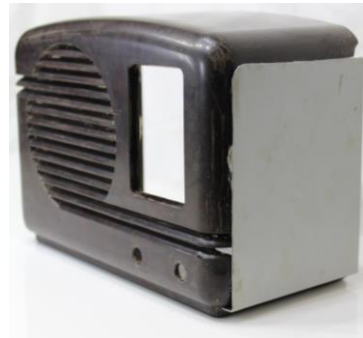
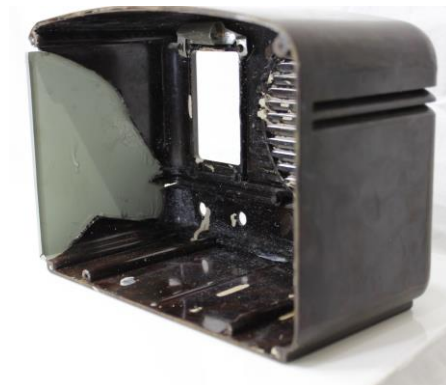
disassembled Akai tape deck commended itself as a superior way to go. The metal would provide an even exterior surface and then filler could integrate the metal with the contours of the case. The metal top cover featured a thin-lip on one edge, closely matching the thickness of the Bakelite, and a right angle return that could create a clean line at the bottom of the reconstructed side. After some careful work with tin-snips the new side was clamped in place and glued with Araldite.

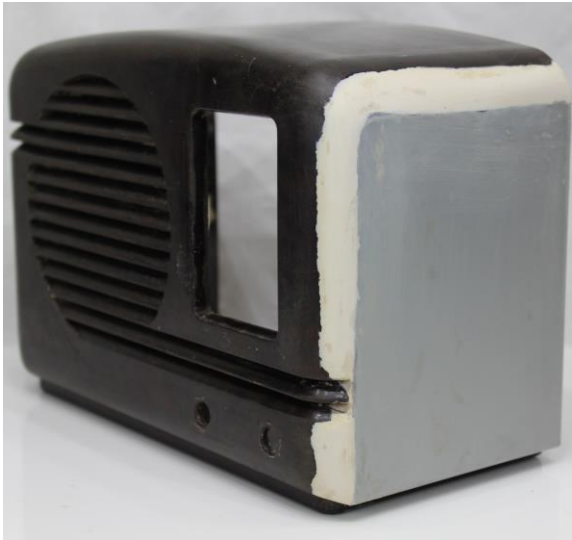
Two-part epoxy car body filler was used to blend the metal to the contours of the case.

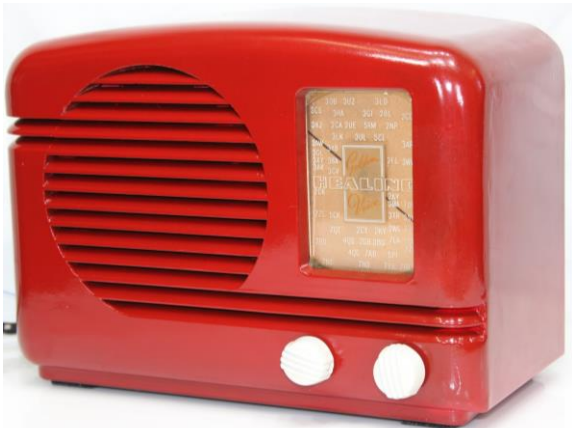
The integration was completed by coating with a filler-undercoat that was sanded back finely to achieve continuity of the surface. The double indentations through the side of the original were lost, but this detracted very little from the final appearance, at least in the eye of the author.

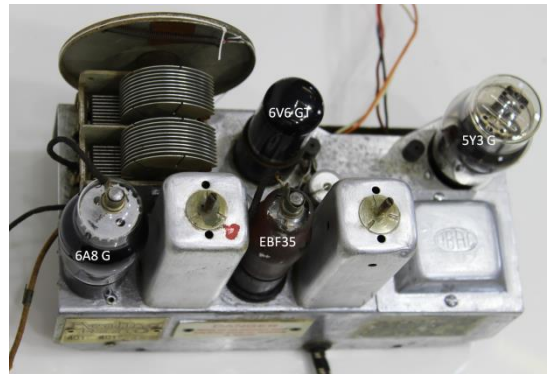
With the case on the way to restoration it was time for the electrical parts to receive attention. Apart from chassis rust and grime the radio was in remarkably good condition. A cleaning by brush using turpentine with a compressed air blow-dry resulted in a clean but still tar covered chassis, notably the stained IF transformer cans. Steel wool removed both the rust and the tar. Rust patches were painted over with chrome-paint.

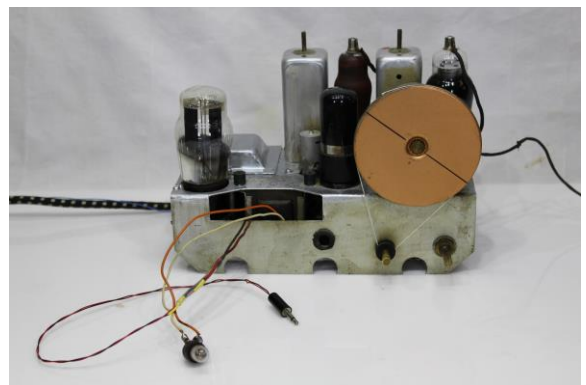
The dial was operated by kitchen string and this was upgraded to genuine dial cord.

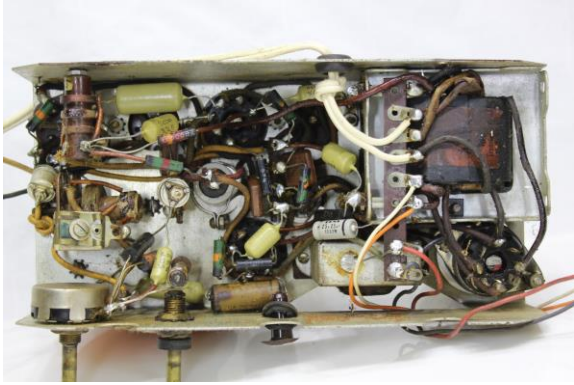
Under the chassis everything looked to be in good order.

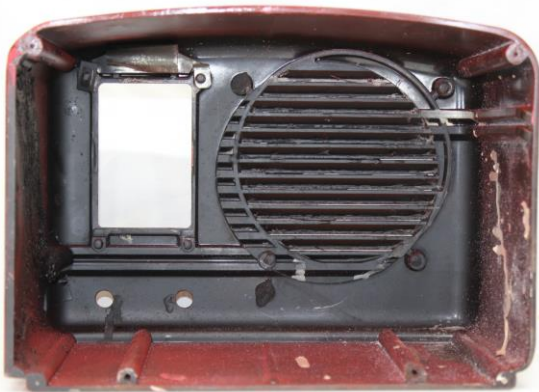
The two-core mains wire was replaced with a three cord lead and this proved to be the only electrical change needed. The mounting studs for the speaker were broken and there was no obvious way to engineer a secure mechanical mounting. Consequently the five inch Rola speaker was rewired to connect to the chassis via a 3.5mm jack and the speaker was glued to the case with Araldite. The speaker and cone were in excellent condition and produced a credible Golden Voiced reproduction. Interestingly the front view of the radio shows a speaker grille larger than the five inch speaker. The rear view of the case moulding shows how this size exaggeration was achieved by adding a solid-fill section to the side of the speaker.

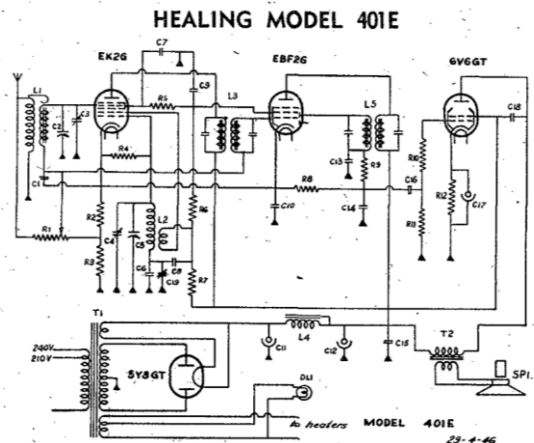
stocks of valves from 1941 to use whatever they had on hand. For this model the 1946 Australian Official Radio Service Manual describes the use of either a 6A6G or EK2G as the mixer-oscillator. The circuit diagram has an EBF2G as the IF amplifier-detector, but this radio has an EBF35. The 6V6 output pentode and 5Y3 rectifier dissipate most of the 28 Watts of measured power consumption and this may explain the lowering of the mains transformer into the chassis to better ventilate these valves. The case gets quite warm in use, but not blisteringly hot.

In analysing the circuit diagram I was baffled by the lack of a volume control anywhere between the IF and audio stages. It was a surprise to locate the volume control as R1 over with the aerial circuitry. The volume is controlled by adjusting the RF-sensitivity and this has some advantages and some peculiarities. The advantage is undistorted reception of strong signals. Magic 1278 in Melbourne has its transmitter about one km from the author and many radios display RF-overload. The 1278 station was received without

distortion by the 401E because the volume control is an RF gain control. The downside is that almost no other stations could be tuned when the volume was set for 1278. For weak stations the “volume” needs to be turned up full to find them. It is salutary to be reminded of the inconvenience of radios without AGC.

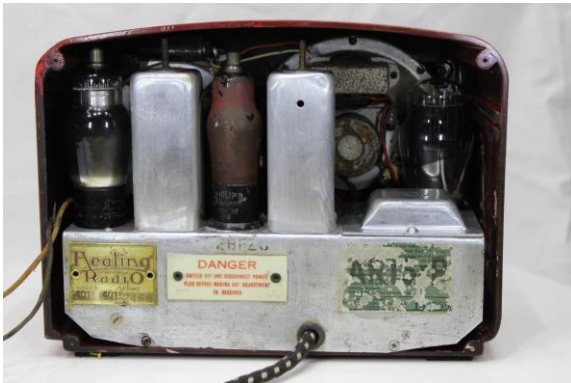
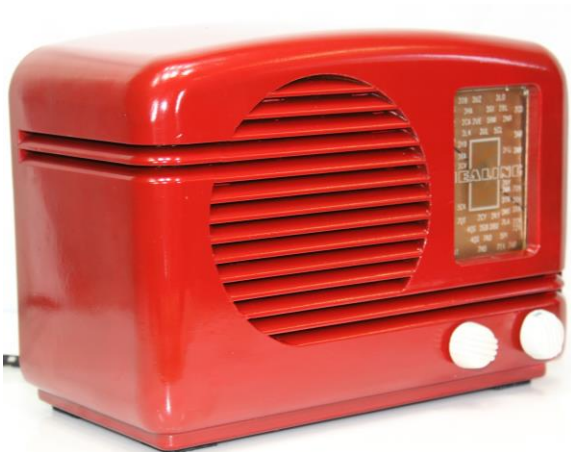
The end result of this project was a radio that brought both aesthetic and listening pleasure.
