# Hotpoint model Z55ME and AWA model 573MA

The only differences evident between the Hotpoint Z55ME and the AWA 573MA are the badge (AWA or AGE) and the lower lettering

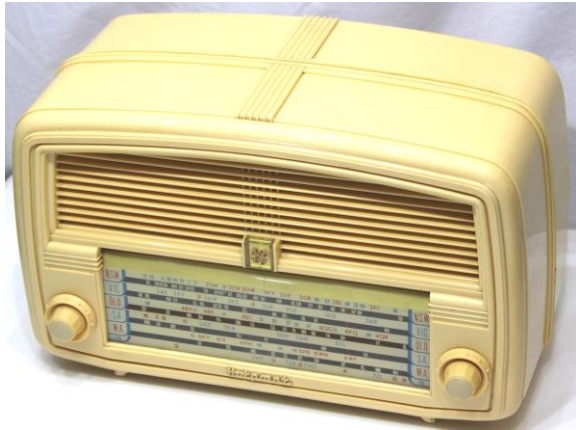
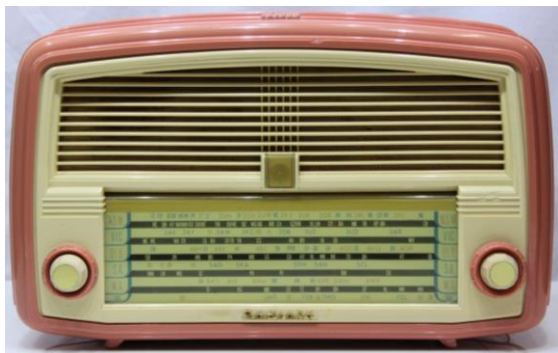
(Radiola or Hotpoint). The case, dials and knobs are all the same, as is the chassis. These radios were introduced in 1955 and AWA continued into 1958. They have the same circuit diagram printed in separate places in the Australian Official Radio Service Manual. I have one ivory AWA and two Hotpoints in my collection. The Hotpoints are coloured pink-mushroom and non-original orange. The case shared by these models is an evolution of earlier styles like the AWA 467MA. An improvement for this radio is that the two halves of the case no longer seal at the junction by overlapping, but they butt with an air space to improve heat dissipation.

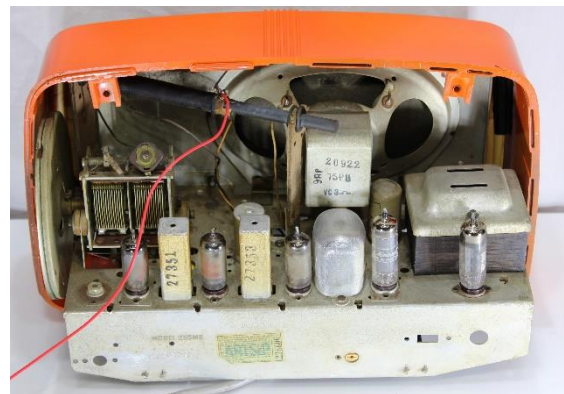
The front end starts with a ferrite antenna that is set diagonally across the chassis. Two coils are wound onto the ferrite and encased in pitch. The external aerial connection is made by a brass spring-clip on the coil former. The point of connection can be seen at the end of the red aerial wire in the photo of the open back. The tuned ferrite coil winding feeds into the grid a 6BE6 mixer and is heterodyned with the signal from the local oscillator L3. The oscillator is a Hartley type and has a tuning slug that is reached from an adjustment port mounted on top of the chassis to the left of the 6BE6. This port marks the beginning of a linear sequence of components that follow from the front end to the output. All of the valves are 7-pin miniature types.

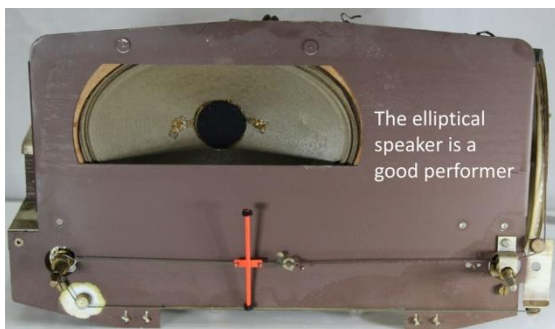
The tone control is variable resistor R13 (100K) and it is the central knob of the two concentric knobs at the left hand side. This knob also switches the mains on and off. The effect of the tone control to my ear creates a muffled sound at maximum bass and a rather

strident sound at full treble. My preference with this radio is to back-off slightly from full treble.

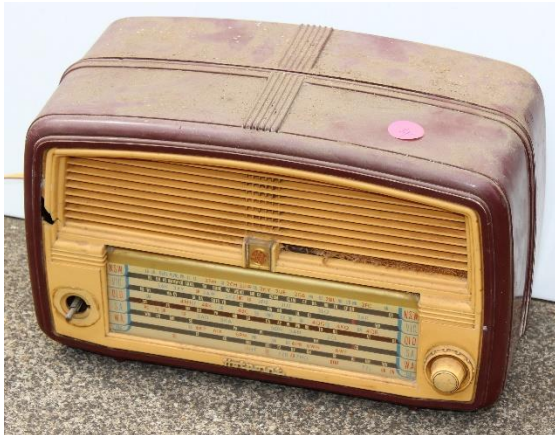
The case was free of cracks. This was surprising because something had been forced into the grille creating several cracks and deleting a bar of the grille. The cleaned halves of the case were prepared for a colour change by spraying with Emoleum flat white primer purchased from Bunnings.

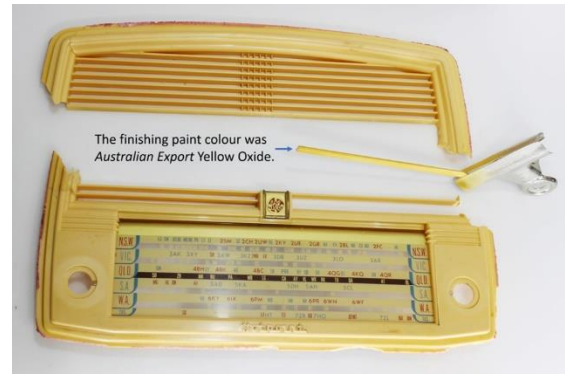
The grille had a chunk missing that had fortunately fallen inside the case and was able to be glued back in place. There were multiple cracks in the grille and all were repaired using Revell plastic model glue.

The missing grille bar was fabricated from a strip of plastic that was originally a part of an AIWA dictation recorder. This followed a rummage through my plastic bits bin. The photo shows that the plastic had been previously used for other replacements. A strip for the grille was hack-sawed off then smoothed and profiled with a file and abrasive paper. The bars have a V-profile cross section with the narrow face to the front. The replacement bar was undercoated then finished with yellow oxide paint branded *Australian Export*. The result was almost indistinguishable from other grille bars.

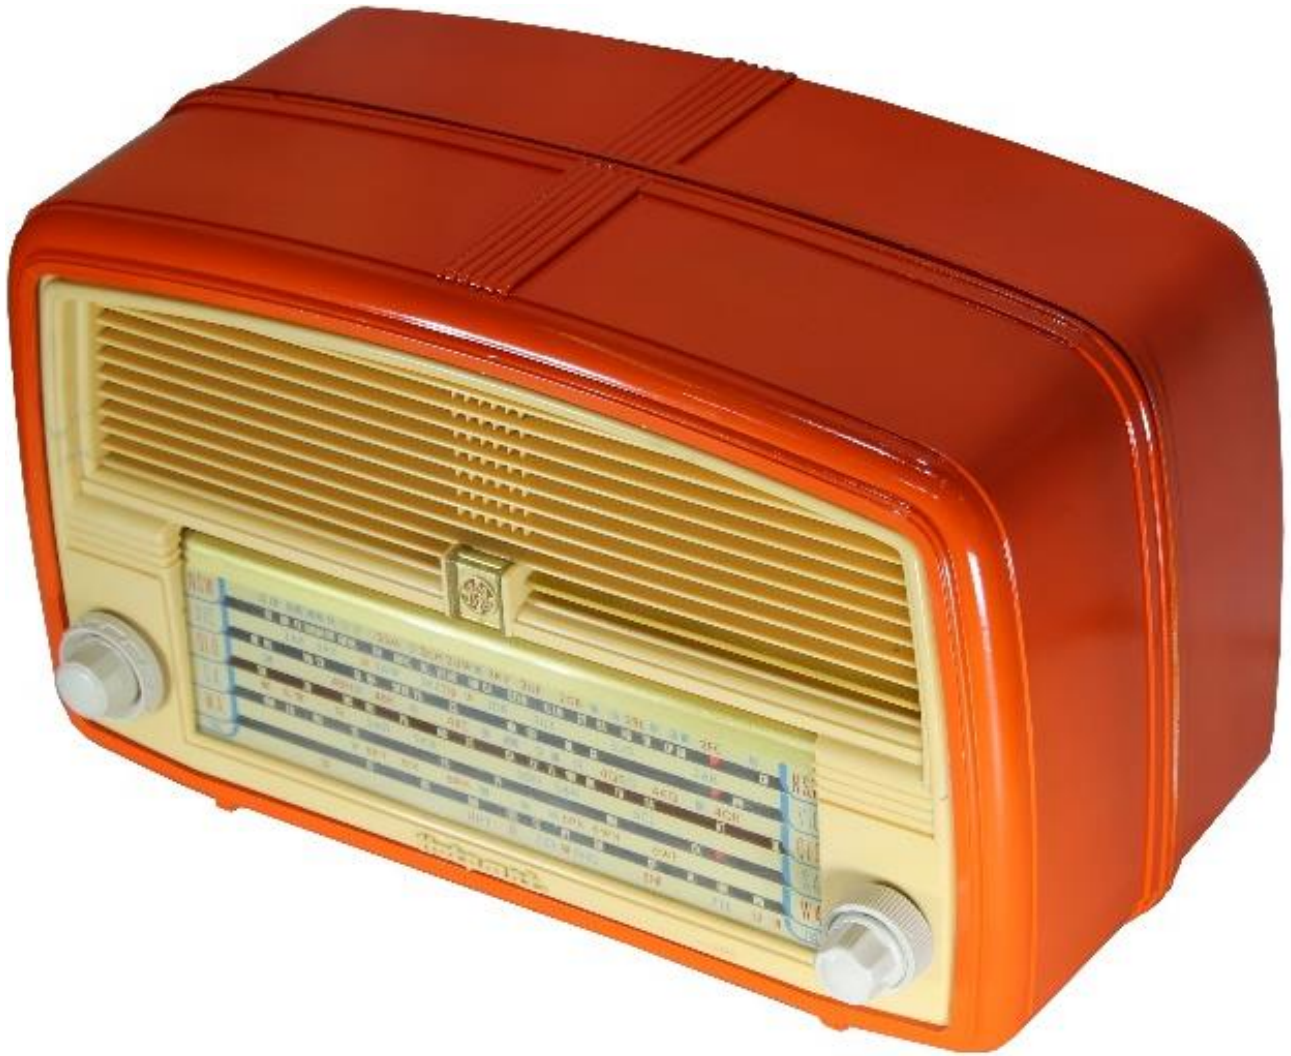
The single original two-part knob on this radio was transferred from the tuning spindle to control the volume and tone, driving concentric spindles independently. No genuine knobs were in my collection, but with patience a set may turn up. For this restoration a replacement tuning knob was cobbled together by gluing an STC knob to the top of a Pye knob to create the best approximation I could from the knobs in my bins.

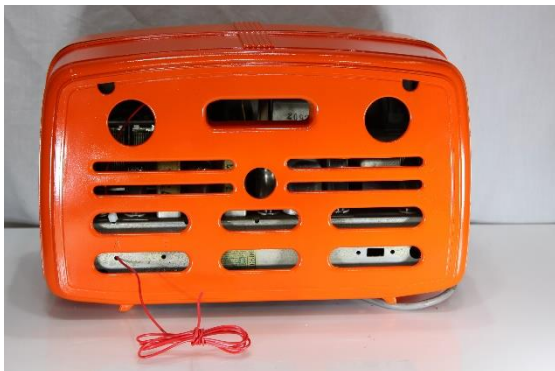
The first step in electrical restoration was to replace the figure-8 mains cord with three core cable to earth the chassis. The radio worked at turn-on, but with a fierce crackle. Three capacitors were obviously replacements

before I started. The remaining chocolate-dip paper capacitors were all replaced except for C22 (0.4uF) in the audio feedback link that is a non-critical component with no DC volts applied. The crackle remained fierce.

Original view of the components under the orange Hotpoint. Three new caps already in place. All other paper capacitors were replaced.

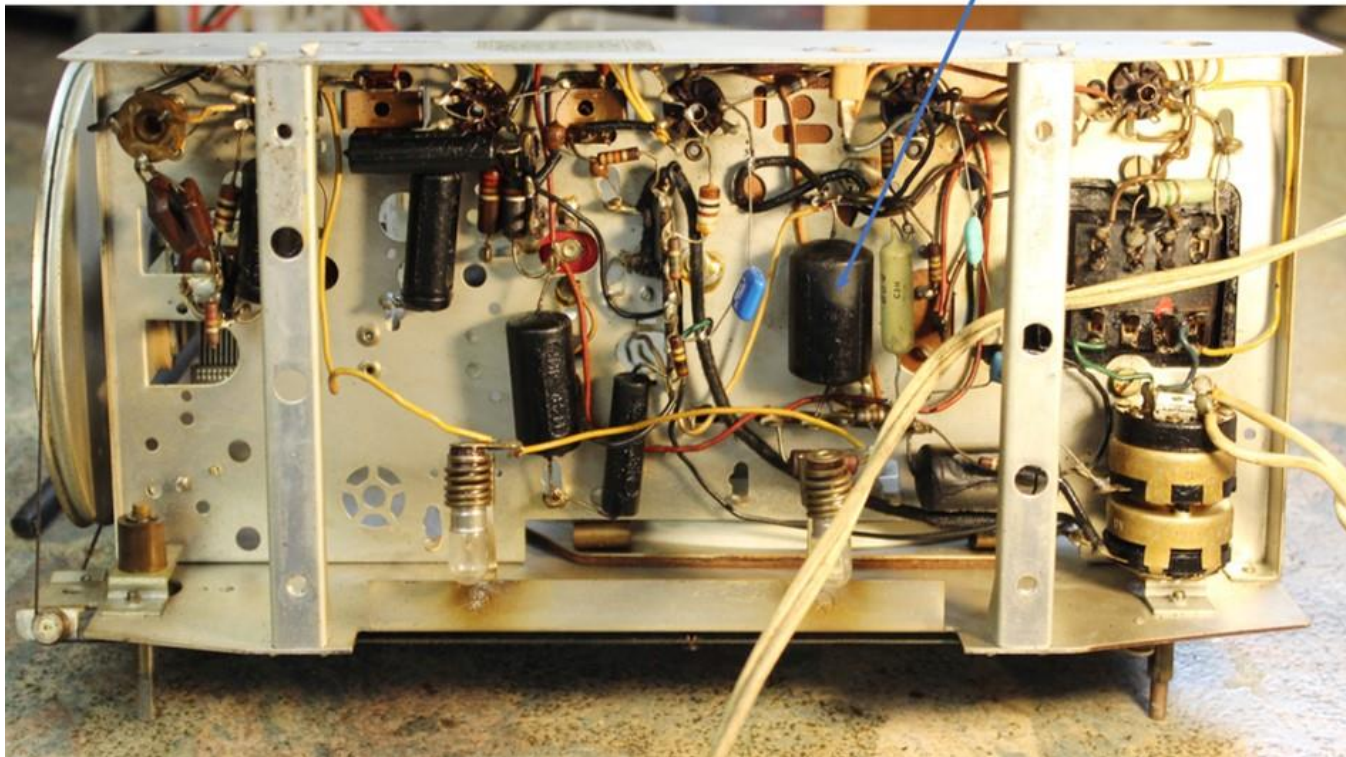
An exception was the 0.4µF feedback capacitor from the speaker.

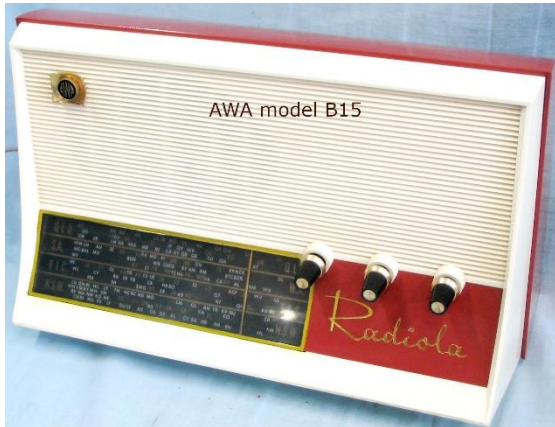
Using a signal tracer- no crackle at 6AV6 grid. Crackle detected at 6AV6 plate. Cutting C20 led to no crackle.
