## Philips portable valve radios 1948 to 1957

By Graham Parslow

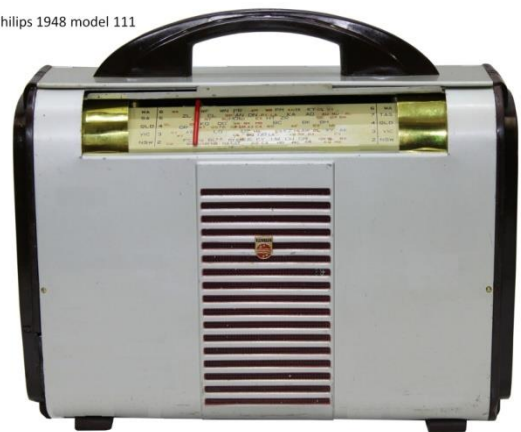
Philips 1948 model 111

The circuit of the model 111 incorporated four miniature valves and one octal valve (a 1Q5) for the output. That output valve was quickly updated to a miniature valve type 3V4 in model 111B and subsequent revisions.

The circuit of model 111 shows a 1T4 used as an RF amplifier at the front end of the circuit and, unusually for an RF preamplified set, this is the only tuned circuit for station selection by the two-gang tuning condenser. The second gang is used by the oscillator to generate the 455 K Hz IF.

Philips gets my vote as the manufacturer most consistently making disassembly and repair of their radios a monumental challenge. In the model 111 the worst construction foible is the inaccessibility of the 1T4 RF amplifier. The subsequent cases and chasses exhibit fiendish tack-on engineering that make bench repairs a chore.

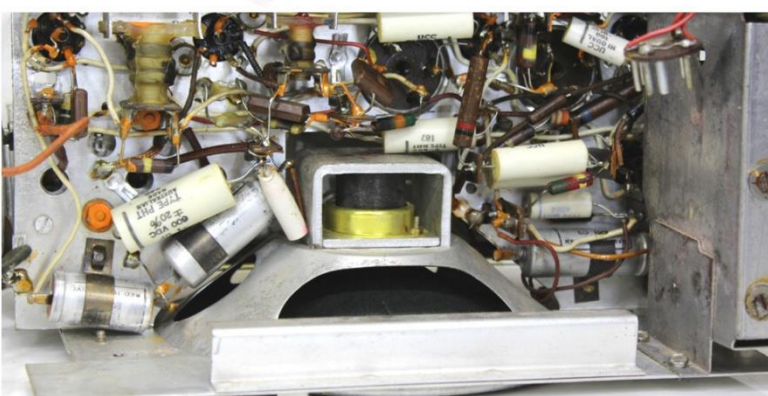
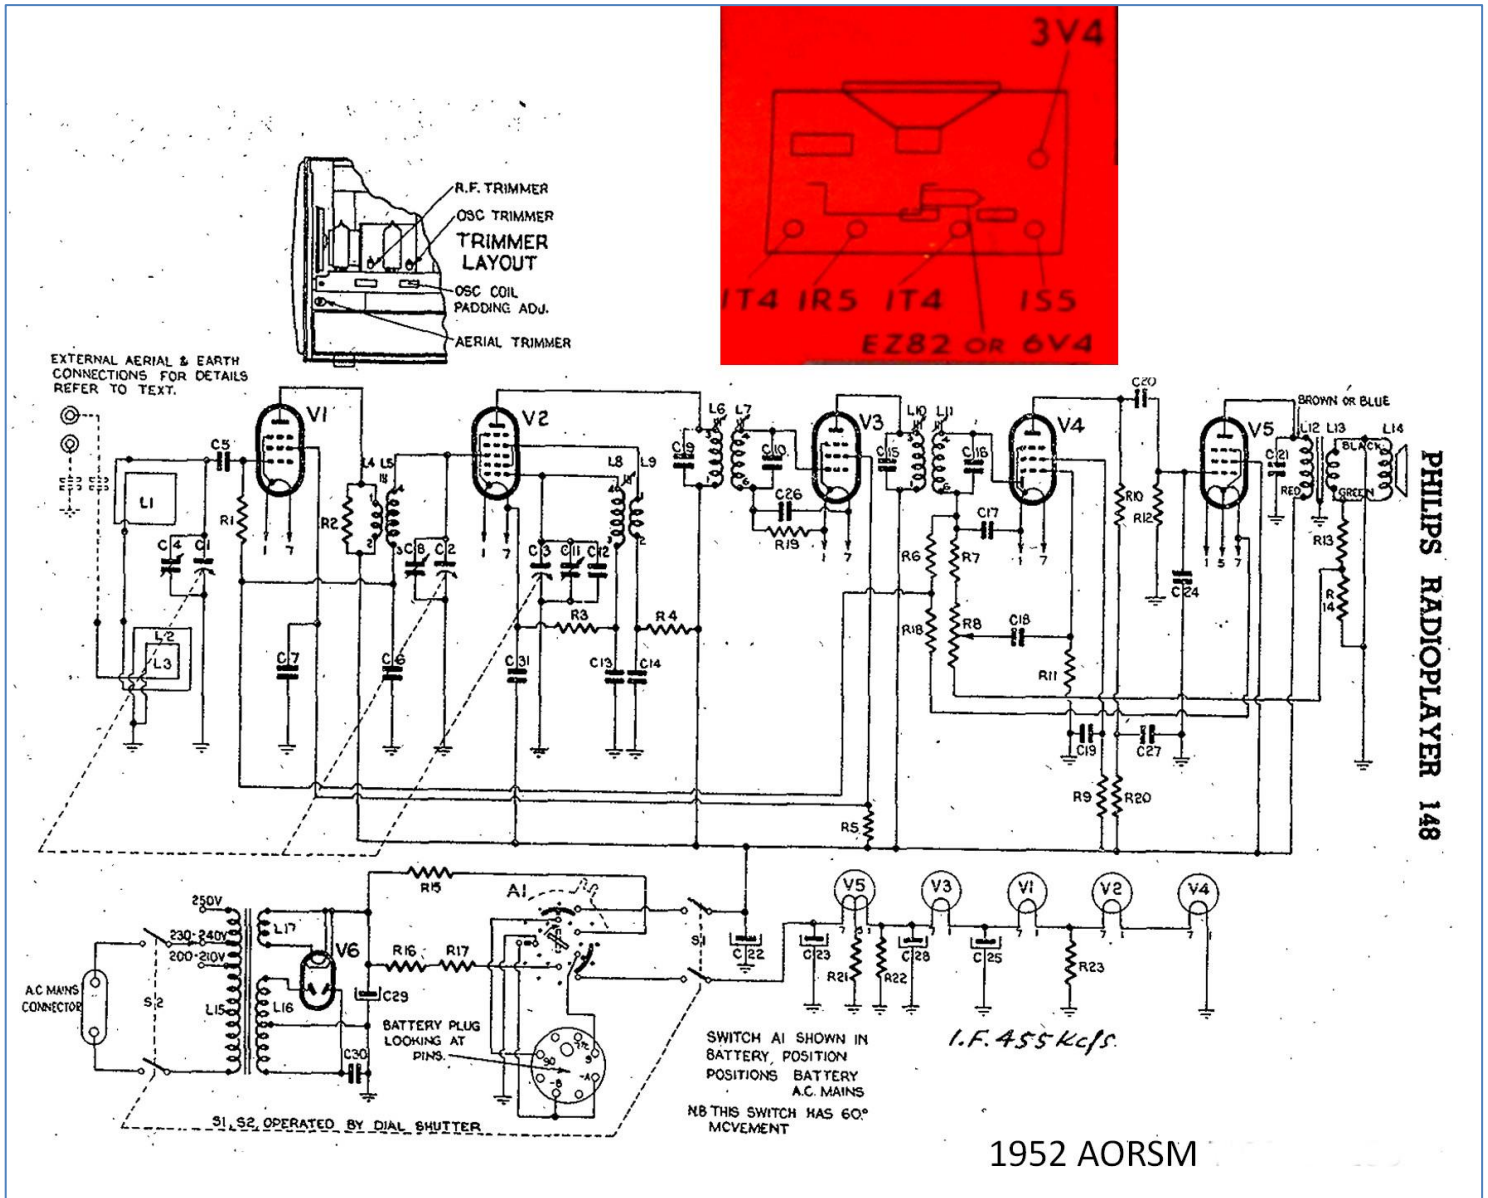
A semi-miniature three gang brass-plate tuning condenser replaces the conventional larger tuning condenser in the model 111.

These fly leads to the aerial coils must be de-soldered to remove the chassis.

The under chassis components are built on top of each other making it difficult to identify and replace "buried" components.

The mains power adapter covers components associated with the 1S5 and 3V4.

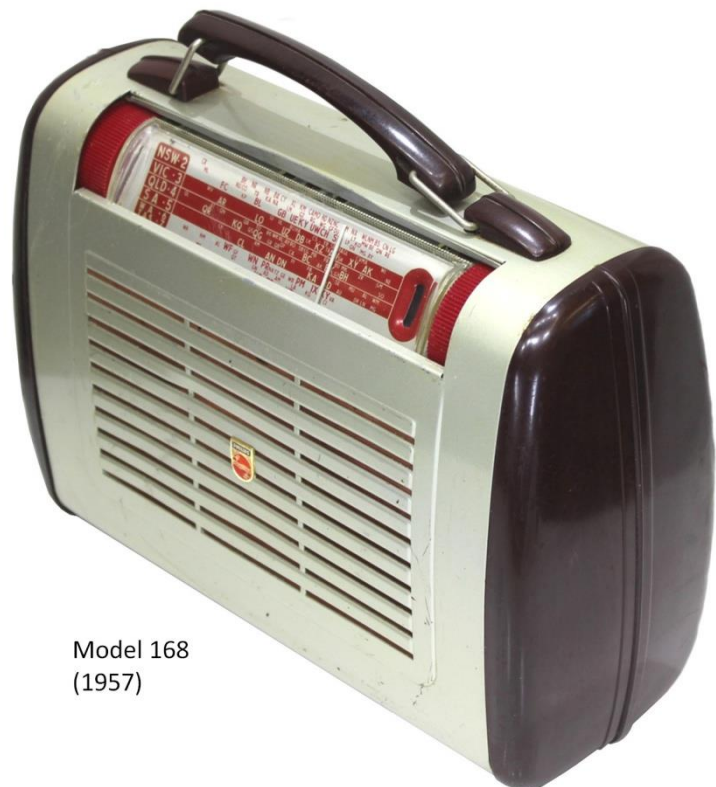
Model 168 (1957)

By 1956 the model 168 circuit had been augmented with a DM71 magic eye valve for tuning. The magic eye is the type used for level meters in portable tape recorders of the time. The end of the line case for model 168 is easily recognised by the red used in the control wheels and the dial lettering. Thankfully these latter models used a clear plastic dial cover that avoids the yellowing, warping and cracking of the celluloid previously used. The side-on picture of model 168 also shows the simplified

profile of the end panels and the flat base that is stable without the feet previously fitted at

the base of the case.

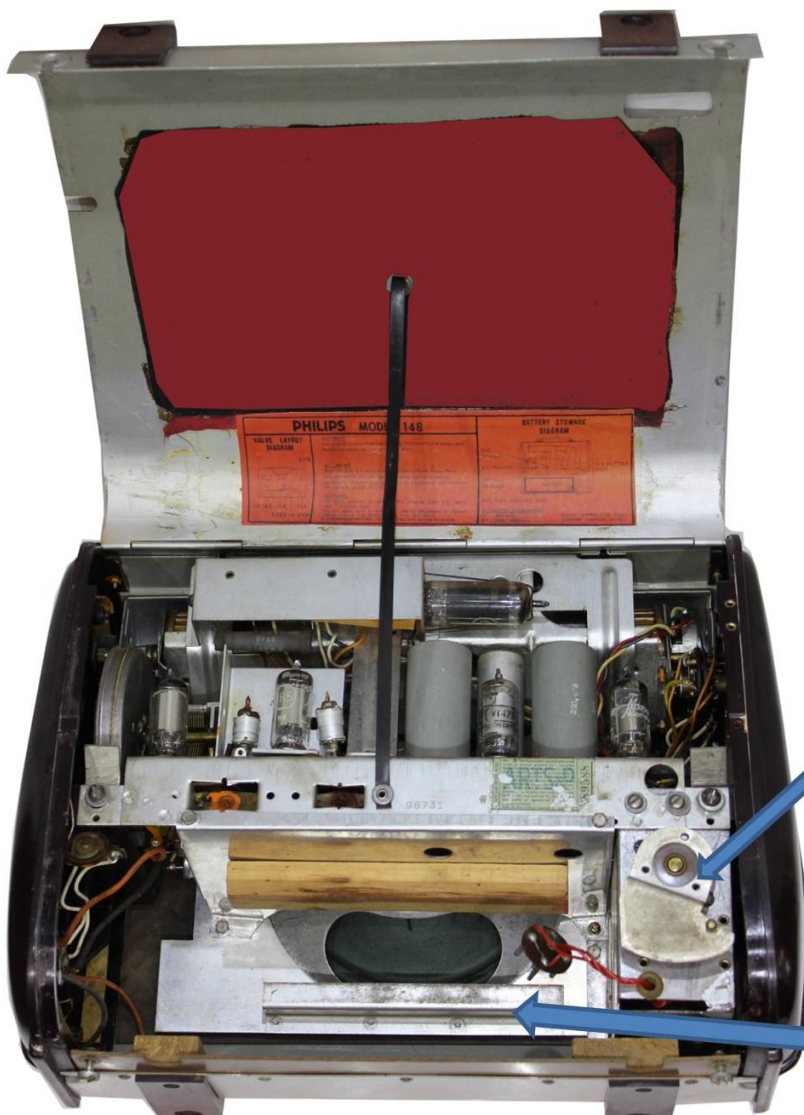
The model 148 of 1951 retained full size IF coils that were soon downsized to the commonly installed miniaturised Philips IF transformers of the 1950s.
