# STC 1941 model 831: a story with a not entirely happy ending

By Graham Parslow

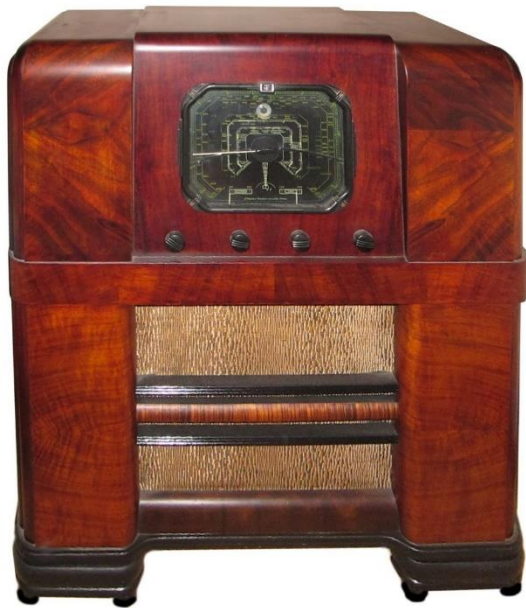
A collection begins with a first item and this STC was the beginning of my vintage radio collection, back in 2004. It was from a collectables shop in Yackandandah. The family that ran the shop were grieving for the death of their grandfather and it was some of the descendants that I bought this radio from. The people in the shop were not the regular proprietors, just helping the family out. They were trying to dispose of as much of grandpa's estate as possible to clear space. At that stage I had no idea how much the radio was worth and neither did the sellers. I offered them \$200 and everyone was happy. The radio got me started on finding literature to learn more about my treasure. I purchased Brian Smith's reprinted 1938 STC sales manual and that book did not have my console case in

it. A picture in Rod Smith's *Best Years of Australian Radios* p125 dates the case to 1941. The ARTS&P is stamped with a "G". All information suggests that 1940-41 is the correct period for this one.

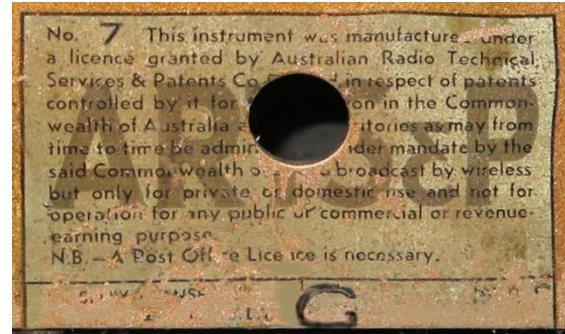
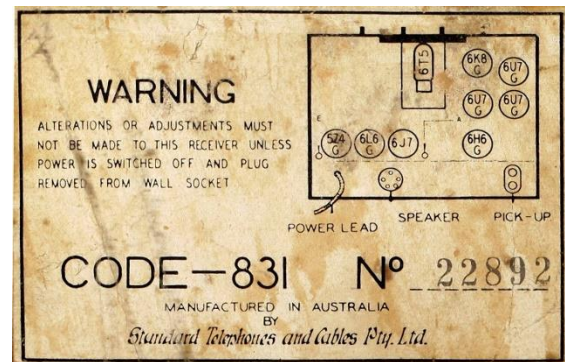
The ARTS&P designation as No. 7 is also informative because it indirectly indicates the number of valves in the radio. More precisely No.7 refers to the number of electron paths that are subject to royalty payments. Most radios are licensed with No. 5 decals. The STC

831 is a top shelf design with nine separate valve envelopes. Unusually the diodes for AGC and detection are in a stand alone 6H6 miniature octal valve. This small valve is nevertheless enclosed in a full size valve shield.

The top of the case was physically abraded and affected by heat from the valves, but otherwise the case was in reasonable condition. I stripped the entire case and

lightly stained the centre section of abraded ply-wood with a Rosewood tint. The case was then finished with polyurethane.
