Scharnberg Strauss – the 1950 model 52 manufactured in South Australia.

By Graham Parslow

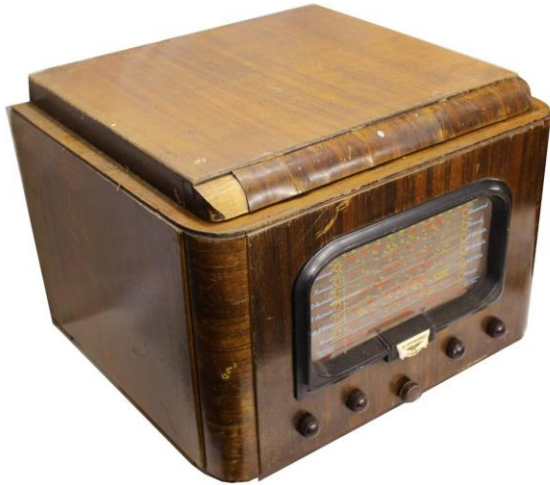
As shown in the advertisement, my radio started off as a radiogram. It remained as a potential project for seven years stored in a ceiling space.

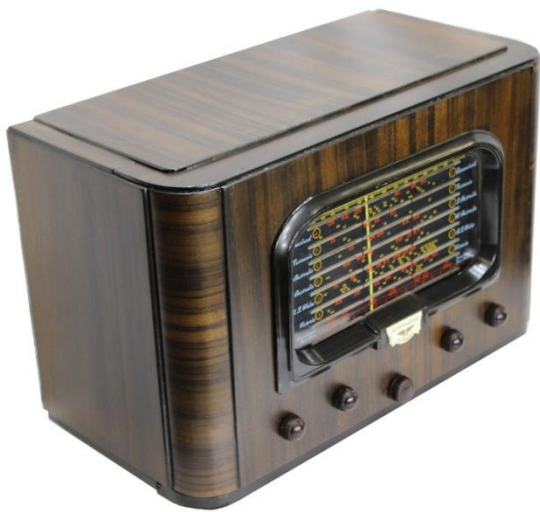
After some reflection on the multiple difficulties of keeping the unit as a radiogram the decision was made to give this one rebirth as a radio only. Unlike the magician who joins ladies back together after cutting them in half, this one lost its rear end.

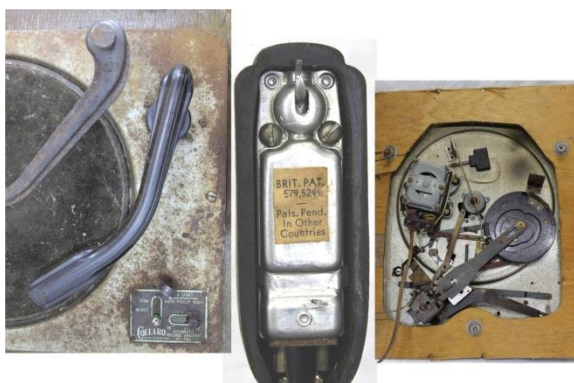
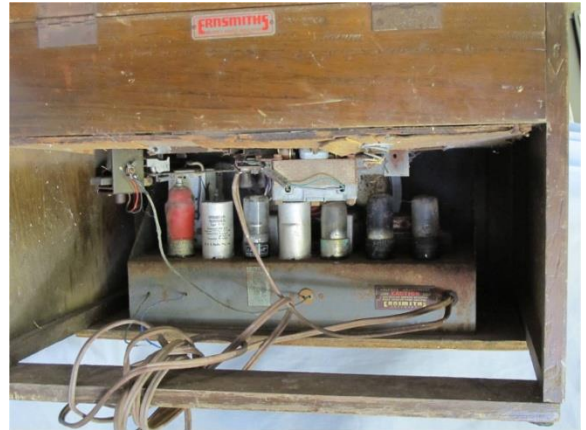
The Collaro turntable built into the table-gram is a monument to solid engineering. Even so it is not a prospect for seriously playing vinyl records in this millennium.

The rebuilt case was a delight to sand back to bare wood and respray with matt polyurethane. The impressive plastic dial has slots to act as a grille for the 8 inch Rola speaker behind it. The grille is well illuminated by 4 dial lamps. The five knobs control On-Off and tone, volume, PU-radio, tuning and band switch. Completing the association with its Germanic name is an eagle on the badge. The more common Bakelite Scharnberg Strauss radio has the same dial, but the model 52 badge and escutcheon are specific to the table-gram.

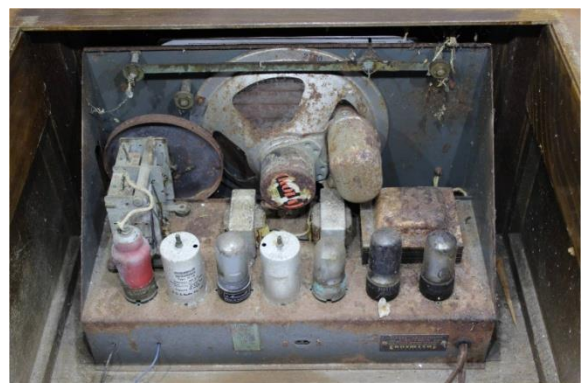
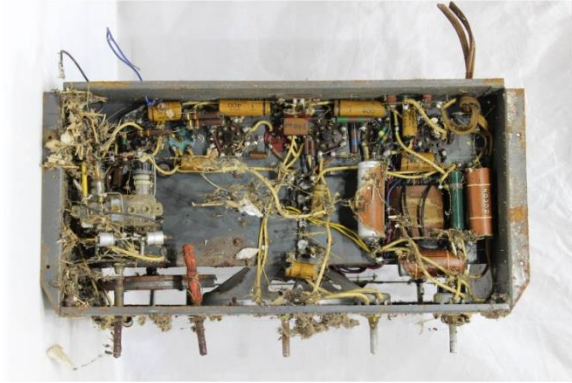
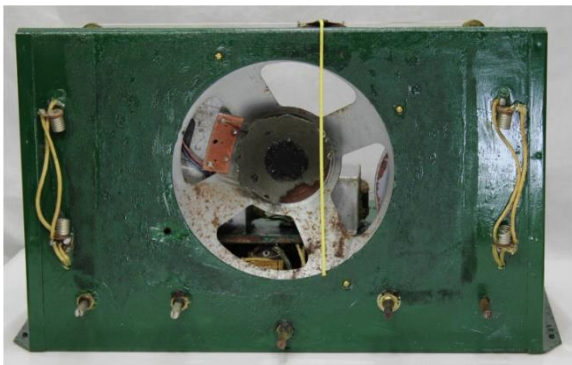
The radio made an attractive display unit after the cabinet was restored, but restoration of the chassis was initially too daunting. It was left as display only for another two years. The problem was that the radio had hosted nesting mice. They had nibbled miscellaneous components that took their taste. Several capacitor coverings were shredded and one of the two chokes had been chewed through to expose broken wires. Most obvious was that the speaker cone had become the main course of the mouse diet.

The corroded chassis was sanded back to remove rust then refinished in an Estapol anti-rust formulation of Brunswick Green that needed no primer.

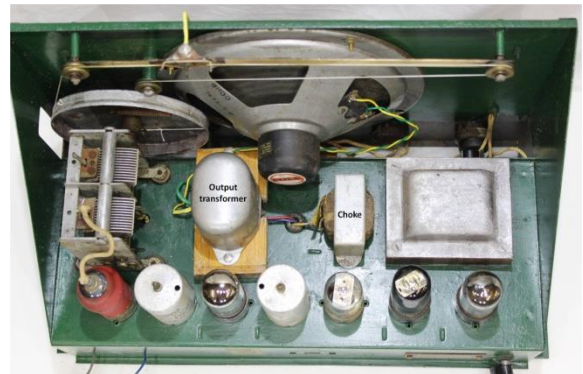
The replacement Rola speaker did not have a transformer mounted on the frame so the first step was to recover the original output transformer and mount it on top of the chassis in the space where the discarded damaged choke was mounted.

The discarded choke was stamped 16 APR 1950 giving a reliable time of manufacture. It was inserted in the HT line to IFT2 that subsequently leads to the plate of the 6SK7 IF amplifier. The remaining choke was measured as having a DC resistance of 538Ω. The open circuit choke was replaced with a 1KΩ power resistor.

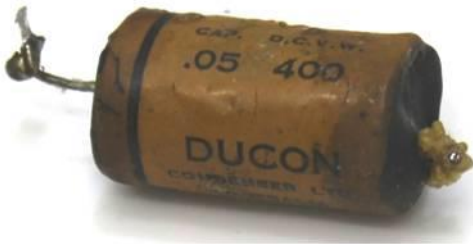
joy, it worked first time and tuned across the dial. However at this stage my finger did not stray far from the power-off switch. Just as well because the power meter was slowly climbing from 50W. A 0.05 μ F capacitor installed in the RF section connected from earth to 246V was warm and on removal gave a comforting confirmation that it was faulty by displaying blebs of melted wax on one of its axial leads.

There are subtleties in the HT power filtering that I did not get on top of so it would be nice to find a circuit diagram for this radio. Even so the lesson I learnt from this restoration is not to be timid in the face of uncertainties.

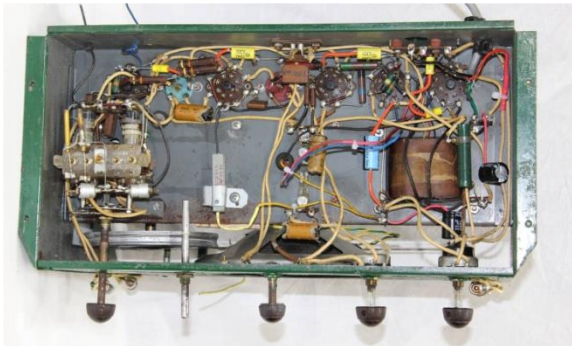
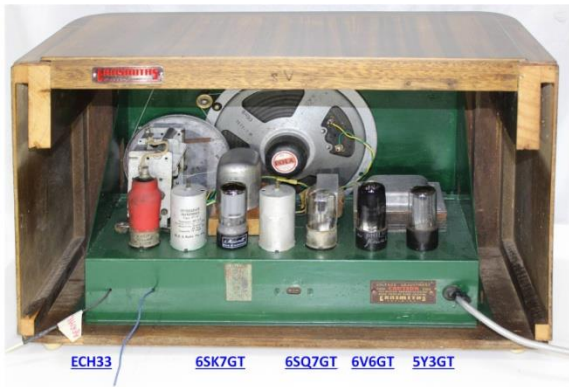
That was it. A magnificently mellow sounding radio was now completely stable as well as a delight to behold. The radio still had a few mouse-nibbled components in place, but that is part of the unique heritage of this radio.
