Tasma 1947-1950 model 1105

By Graham Parslow

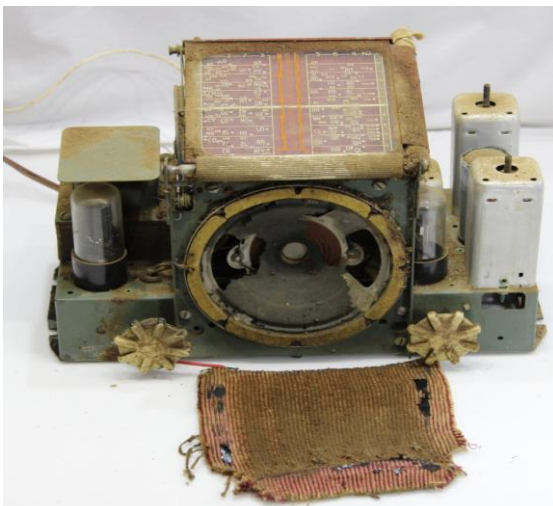
Tasma was a contraction of Thom and Smith Ltd, Mascot (NSW). The radios were mostly sold within NSW, although a complete network of national dealers was established. The radio in this article was acquired new by a farmer at Hay in NSW and it was the family radio for many years. The farmer's son Adrian acquired the radio. Adrian left the farm for a career in finance on the Gold Coast in Queensland. The author likewise resided on the Gold Coast for some years while working at Bond University. If you have lived in a Queensland coastal area then you will know about the rain storms that inundate the area. Sadly this radio was in a storeroom that was leaky and it suffered from immersion in muddy water. When removed from the case the chassis showed the mud and corrosion that was expected from this circumstance.

Adrian gifted the radio to me on the understanding that it would be restored and brought back to life. After collecting the radio on the Gold Coast and returning to my current hometown of Melbourne the challenge was overwhelmingly seductive. A couple of intensive days went into the restoration and Adrian commented "I nearly can't recognize the radio, you have done such a great job in such a short time!" The gratification of a successful project is even greater when it is shared with someone connected to the history of the radio. The radio was indeed a sad sight to begin with and pictures tell the story well enough.

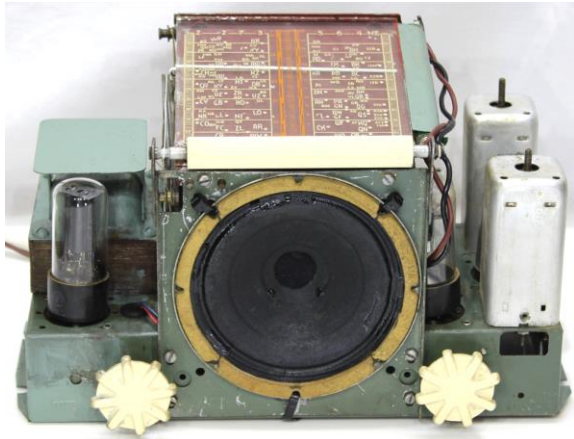
The speaker cone was in tatters so the speaker was removed and replaced with a same model 4" Rola from the spare parts shelf. The speaker transformer was OK and was mounted on the replacement speaker. The chassis was selectively washed by a wet cloth with degreaser to remove caked on mud. The white tuner roll-bar was particularly demanding to get clean. A scrubbing with mineral turpentine followed, then a compressed air blow-dry. The cleaned chassis was painted with a matching green to remedy the worst of the corrosion.

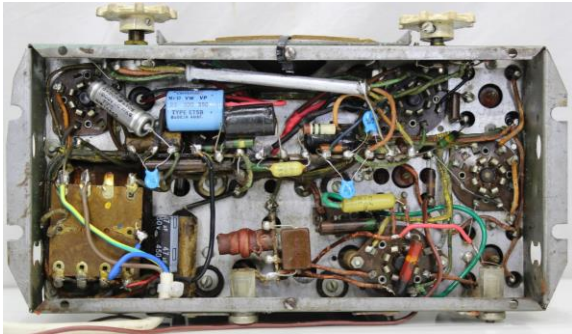
At this stage I decided to take my own advice that I had published in the January 2015 Silicon Chip (restoration of a Stromberg-Carlson model 5A26) and that was that there is value in replacing all paper capacitors to avoid progressive failures. In this Tasma radio the paper capacitors appeared to be progressively

failing so I replaced all that I could reasonably access.

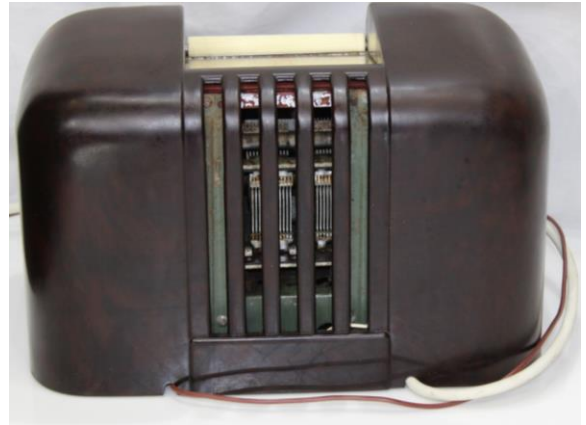
With the radio electrically functional all that remained was to restring the tuning drive. The refurbished case was added and the restoration was complete. The rear view is not the radio's best angle, but it makes a fitting end to the narrative.
