## A tale of two 1955 Fleetwood 4-valve mantels, model 1003

By Graham Parslow

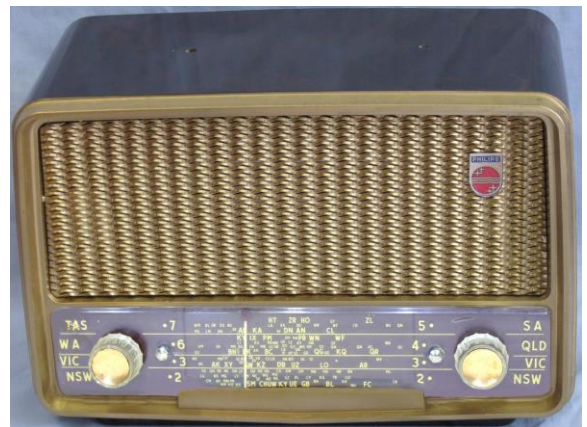
The Fleetwood model 1003 can be distinguished from the electrically identical Philips 164 by having a cloth speaker grille, rather than a metal mesh.

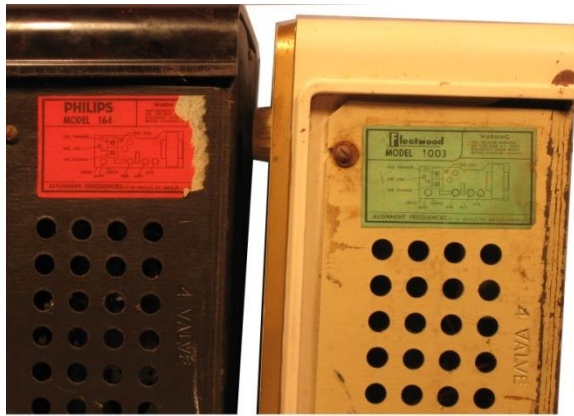
Underneath the Fleetwood and the Philips radios there is more evidence that they are twins. Both have 4 VALVE stamped into the fibre of the wrap-around backing panel and the same information on the labels (Philips is red, Fleetwood is green). Rather strangely the cases could either come as genuine walnut Bakelite (as for the model 164 shown here) or in thermo-moulded plastics for colours such as the cream Fleetwood. This would have been close to the last use of Bakelite because it was more expensive to produce and the fashion of the 50s was for bright colours to match the kitchens.

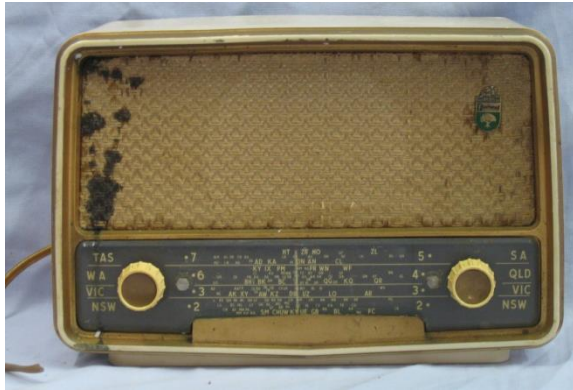
Green corrosion spots were apparent in the gold finish of the case. This suggests that the gold finish was formulated in part with copper. Before restoration the speaker cloth on the Fleetwood was badly stained at the left hand side with a green-black goo that also dribbled onto the gold trim and dial. The goo appeared to be acidic and created a copper salt where it affected the finish. The solution to this cosmetic problem was to thoroughly clean both case and grille with degreaser. The black dial

background and the cream case were covered with masking tape and paper in preparation for painting. The exposed face and grille fabric were then sprayed with gold paint. Although it is not an intuitive thing to do, speaker grille fabric takes paint well and the result was excellent. The cream feature-strip at the front of the case was restored by sanding off the new gold coating with a fine-grit abrasive.

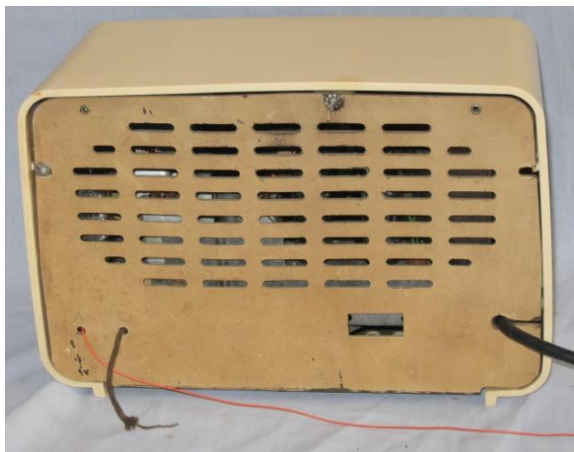
Although the back of the radio was protected by a punched fibre board a large amount of dust covered the valves and top-side radio components. The dust and grime was removed by brushing with mineral turpentine and blowing dry. Before this cleanup a small fragment of the ARTS&P label was evident on the chassis to the left of the power cord grommet. Sometimes I replace the ARTS&P labels with a reproduction, but in this case it could not easily be seen with the back plate installed so it was omitted.

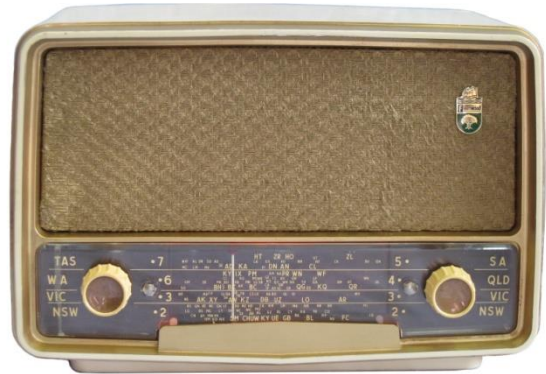
One blemish was not removed during restoration and that was pitting of the dial plastic where the corrosive goo had etched it. Even a deep polish with trusty old Brasso did not go deep enough to remove the pitting. Old Brasso is formulated with kaolin and quartz instead of silica for abrasives and the suspension compounds do not harm most plastics. Those fine abrasives bring back most plastic surfaces to spectacular clarity. The Brasso formula changed in 2008 to comply with

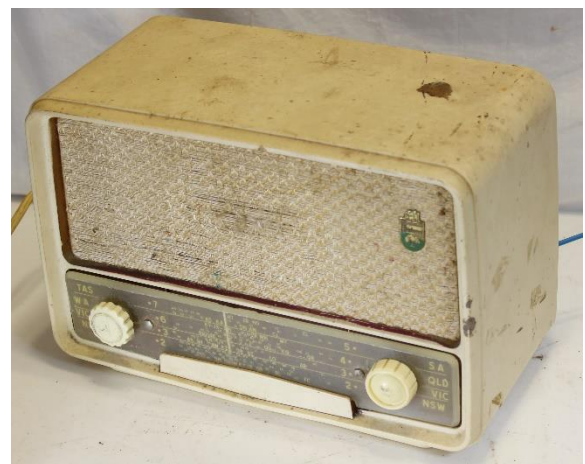
This radio was among several that I obtained as a lot. The grille fabric was frayed, the knobs were of two styles (neither original) and it was grubby with splotches of goo. My first reaction was to move it on untested at a HRSA mini-auction. I should perhaps have kept to that plan. However, I plugged it in and it did not work. This is when the “rise to the challenge” urge set in and I removed the back. This was a bad choice in retrospect when I think how the hours might otherwise have been used.

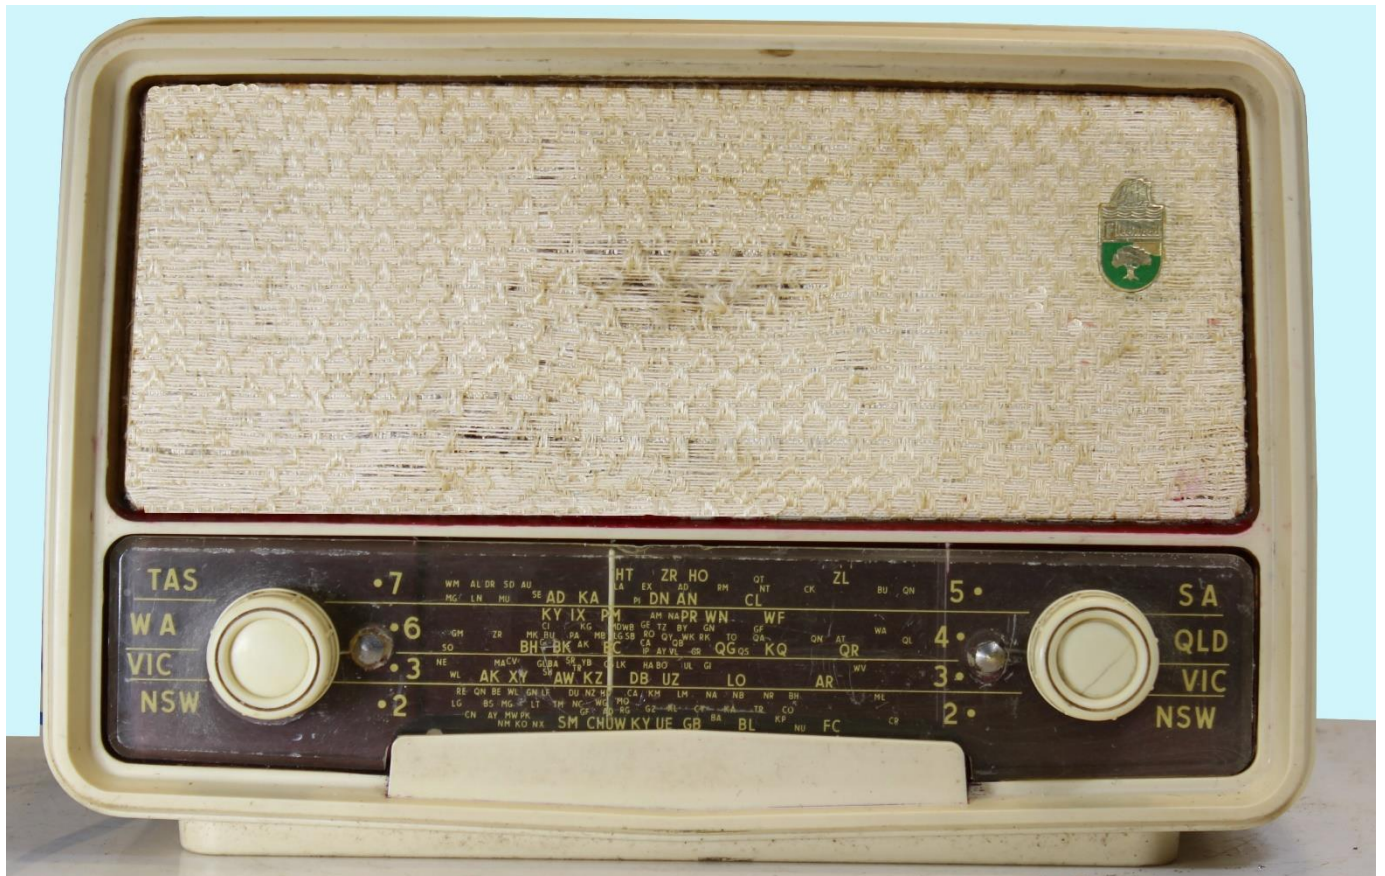
A working radio motivated me to take up the restoration of the case. The original knobs are hard to come by, but a set of knobs salvaged from a different Philips radio made a reasonable substitution. In the end only the distressed grille fabric detracted from the final appearance.
