# AWA 1953 model 541GA, or is it?

By Graham Parslow

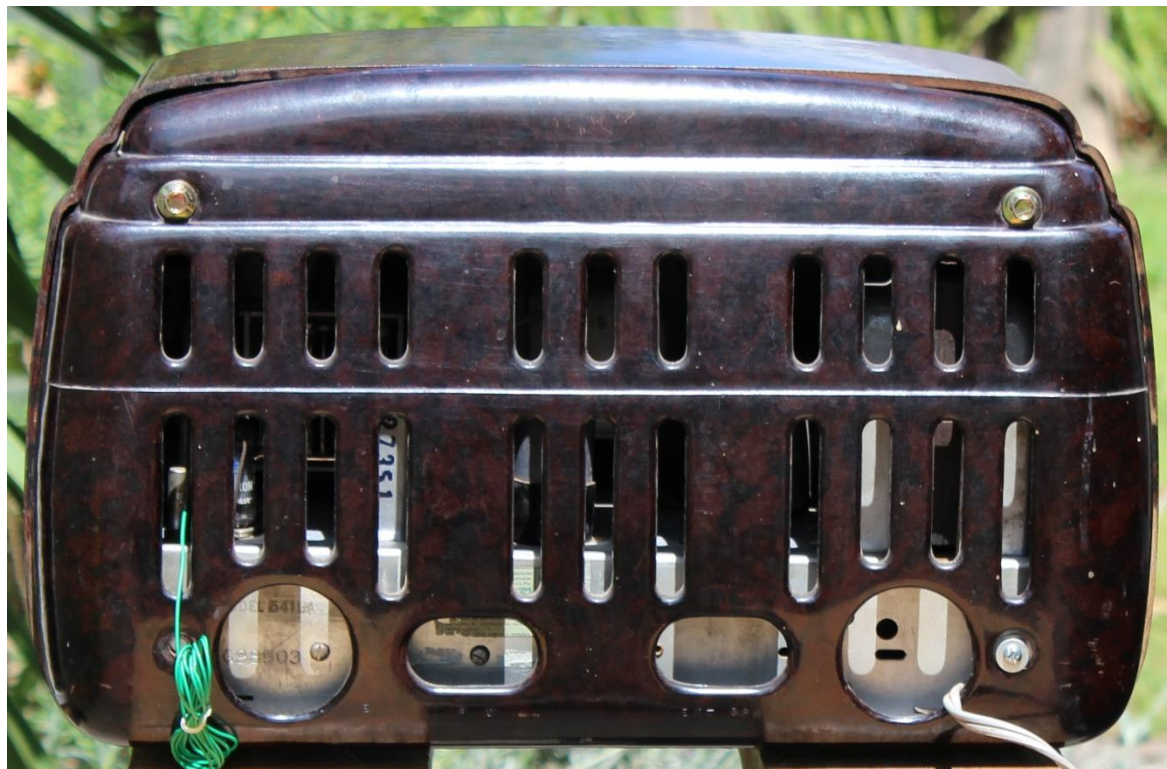
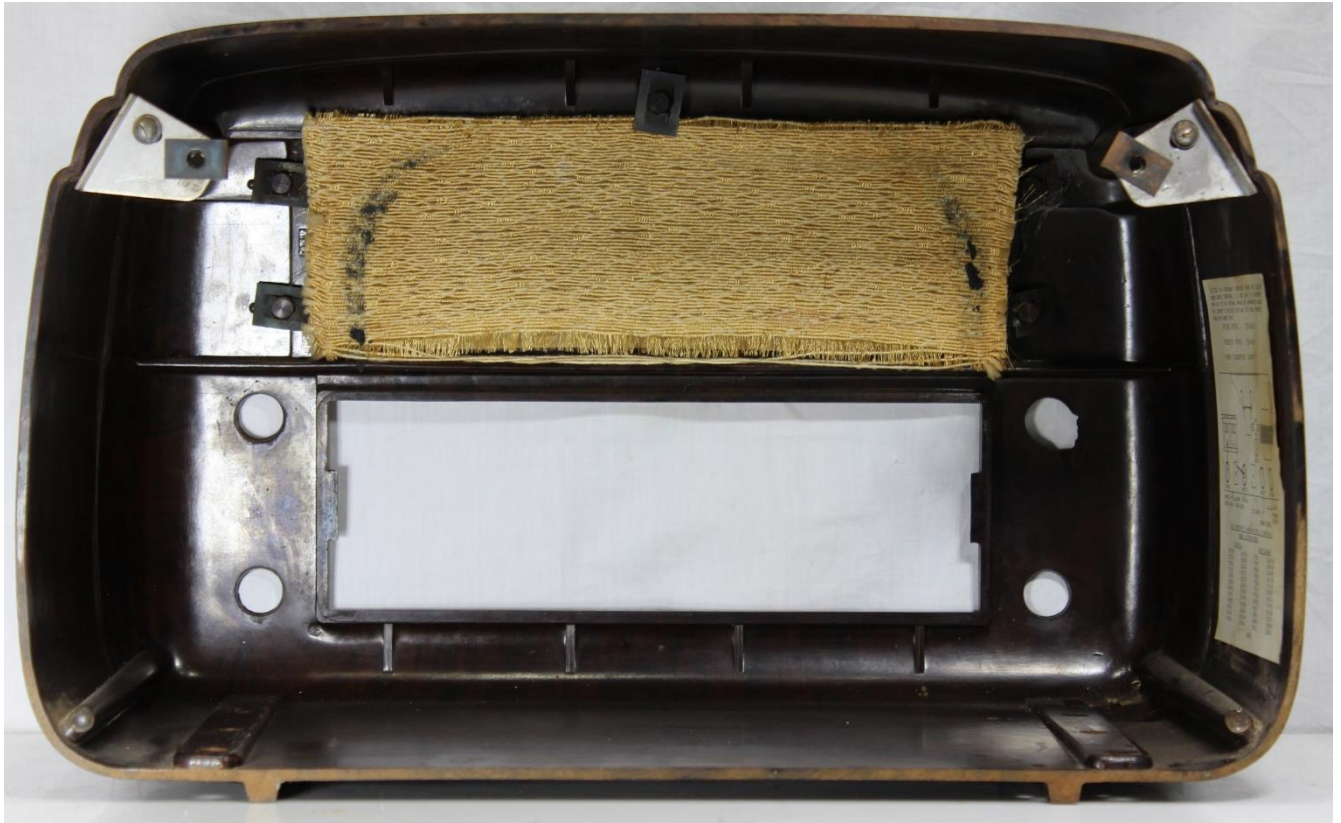
To the credit of AWA they made it easy to identify a model by stamping the ID on the chassis. So, let us take a look at the back.

The first thing to notice is the ill-fit of the rear moulding to the main case. I have come to the conclusion that this was

probably done by AWA rather than a mix and match by a fixit person.

My best clue that this not-quite-right shape came from the factory is the adapter plates fitted to the back of the front case to accept the bolts at the top. The adapter plates move the anchoring point inwards from the Bakelite case moulding. The neat metal engineering and use of threaded clips looks like a factory job. Looking to the paper information panel pasted inside the case reveals the valve placement of the radio, as manufactured.
