HMV 1939 tombstone model 440

By Graham Parslow

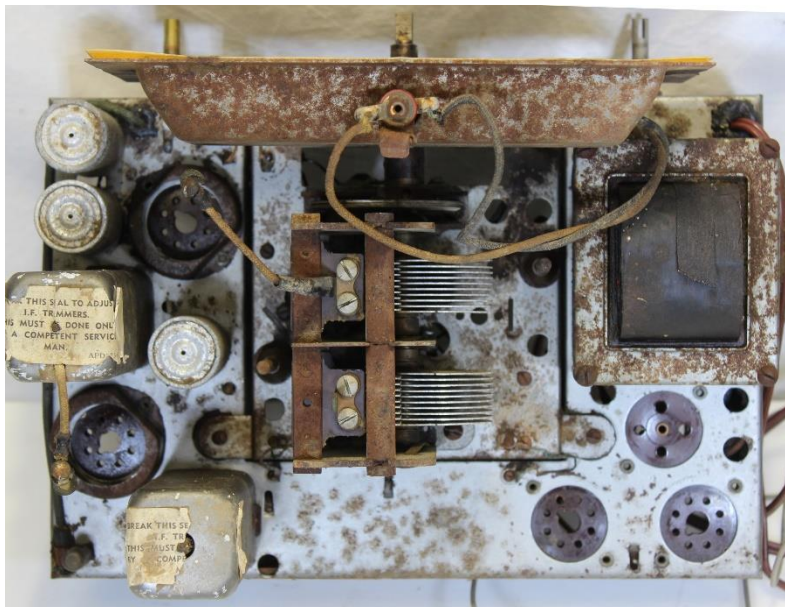
The picture of the cleaned chassis shows the rust that was particularly noticeable on the

dial backing and transformer surround. After some abrasive to remove the worst of the rust, some silver-grey paint was brushed on to give a better cosmetic appearance.

The top view of the chassis shows the four octal valve sockets and the four-pin speaker socket. The first two valves were shielded. The speaker socket was a bit of a challenge to get the right orientation because it was only guided by one pin being slightly larger diameter than the rest. After getting it right I filed a groove into the speaker plug and put a dot on the chassis to show the correct register. During the electrical work that speaker plug went in and out like a yoyo so the orientation groove made this much easier.

The picture of the top of the chassis shows a brown twin core flex leading to the mains. It was left in circuit for the first switch on to establish whether the radio was in working condition. I am ever the optimist. All valves and the speaker plug were installed, but at switch on the power meter rapidly climbed over 140W before it was quickly switched off. The HMV data indicate 56W consumption for this model. The most obvious power sink is

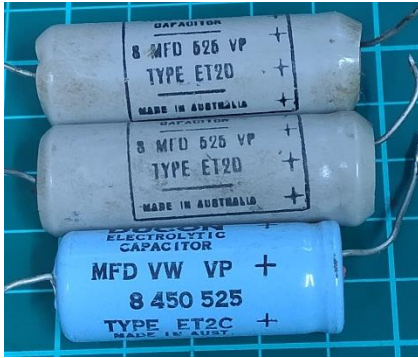
The underside of the chassis was in original condition except for addition the of three Ducon electrolytic capacitors.

The three added 8 μ F capacitors were simply paralleled across the original 8 μ F metal can electrolytics C8, C24 and C25. Leaving the oldies in circuit was not a good move, but I can see why they were left. It was because access to the base of all original electrolytics was near impossible due to being overlaid with bulky paper capacitors

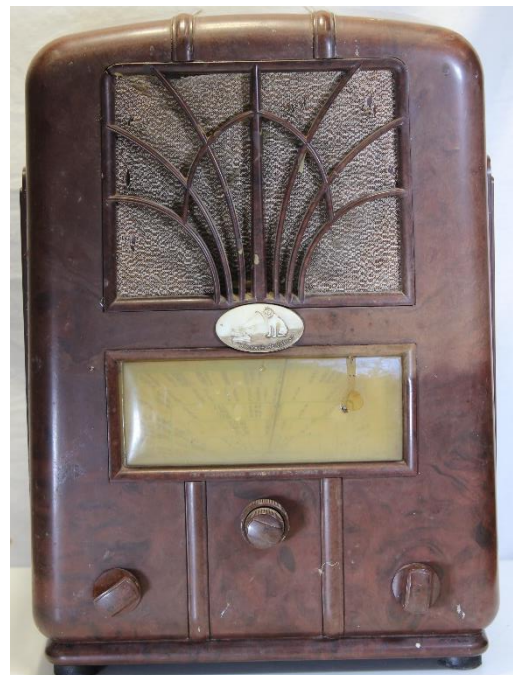
The Bakelite case is tinted conventional mahogany with intricate walnut-like patterns. The true glory of the case was disguised by dirt and the patina of age.

Removal of the speaker was relatively easy by undoing two screws on a retaining bar across the back then removing four nuts around the edge of the speaker. This revealed that the ornate speaker grill moulding was a separately unit retained by four screws. It popped out complete with the grille fabric glued to the back of the moulding. The gluing surface was only 3mm wide around the edge and this presented a challenge to select a glue that would not bleed into the replacement grille fabric and produce unsightly blemishes. I found Mont Marte clear school gel purchased from Office Works did the job perfectly. After gluing an oversize piece of cloth to the moulding a surgical scalpel was used to cleanly trim the cloth flush with the edges.

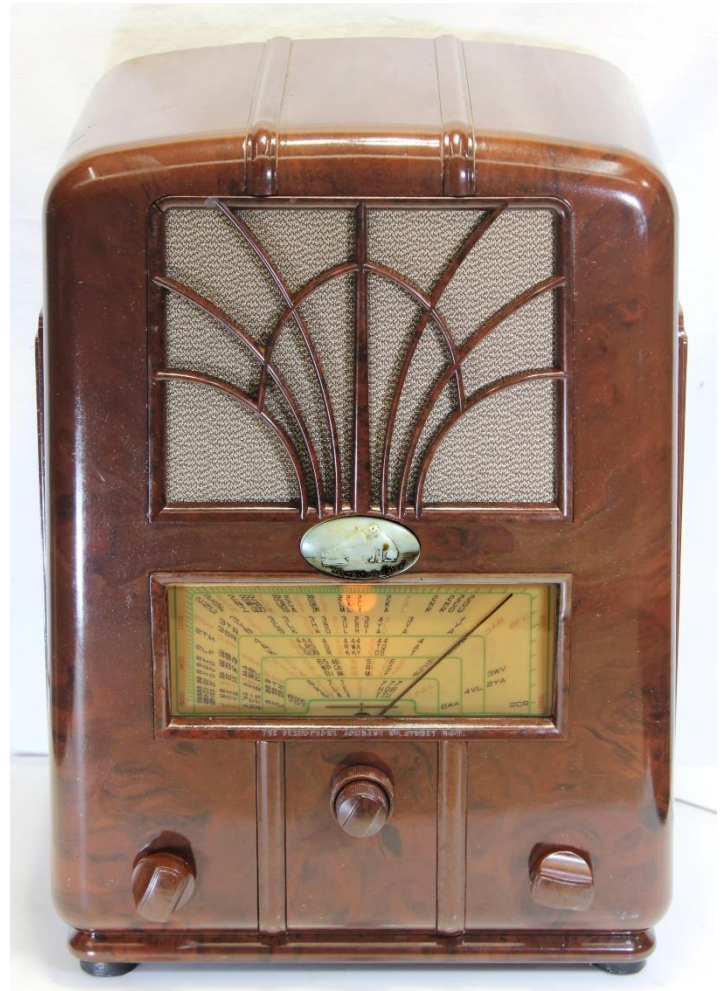
The before and after pictures shown here of the face were taken under the same lighting conditions. This shows how effective some patience can be with restoring a case.

The Bakelite case was soaked in a tub of water for 3 days to loosen up all surface dirt. I try to avoid using harsh detergents because this can damage the surface and reduce the sheen. Careful wiping over with a microfibre cloth and attention to paint spatter spots produced a clean case.

And now for the ultimate secret treatment which can be shared with you. A comprehensive spray with five-star brand silicon-based car-tyre sheen. The spray was

left untouched to soak into the surface over four days with a few hours in the sun to let UV light do its magic. After that a wipe over with a microfibre cloth to remove excess silicon, produced a gloss even better than new.

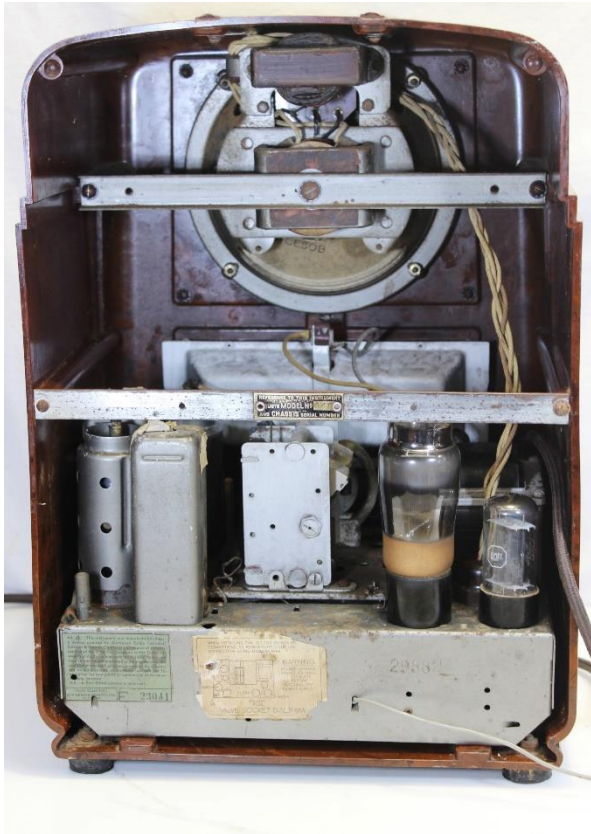
All that remains now is to show the completed rear view.
