# STC 1941 model 831: Part 2, a story with a happy ending

By Graham Parslow

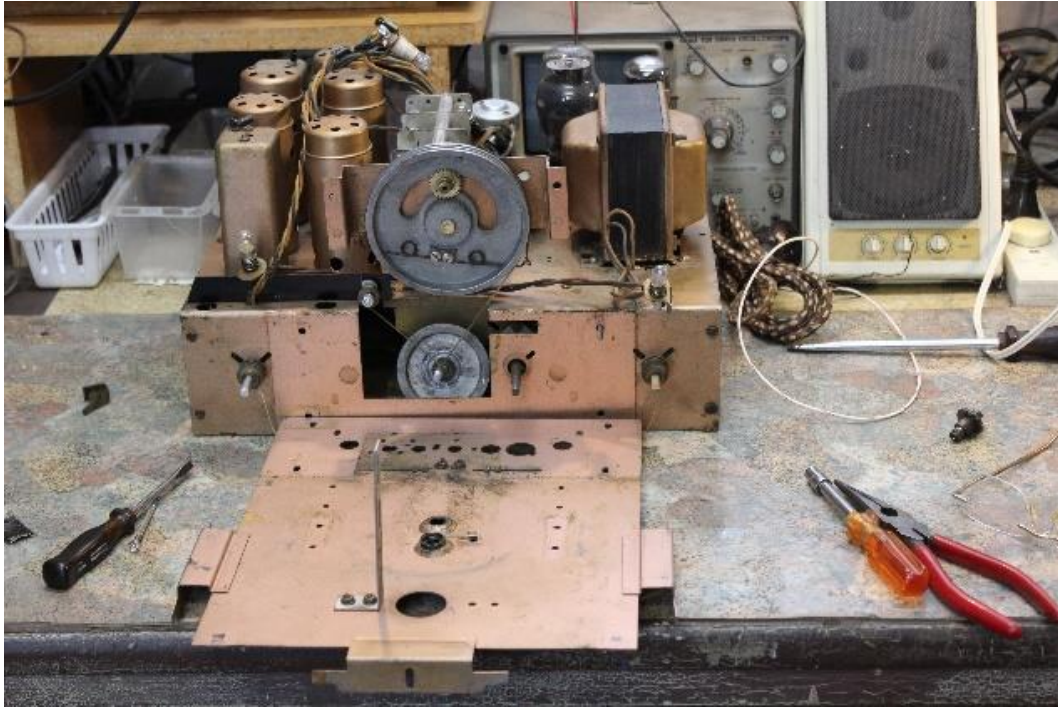
Fig. 5

that rotates the dial drum. When the face plate is free of the retaining screws the drive mechanism becomes apparent (figure 5). As for many better-class systems, the tuning spindle has a flywheel to make station changes smoother. The main dial drum has splines to drive the dial pointer cog.

proved relatively easy to install the replacement drum and cog.

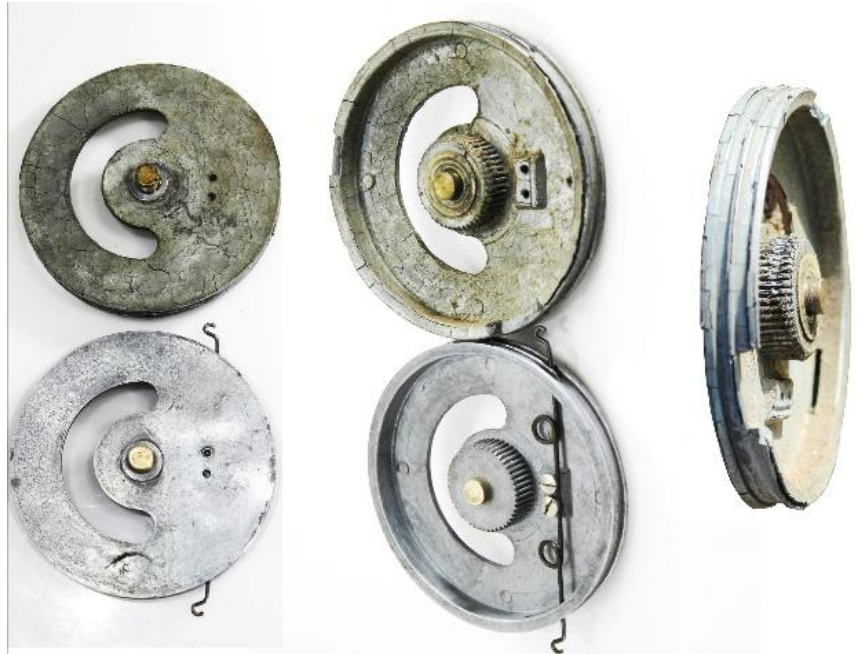
Fig. 6

When the original drum was removed it was immediately evident why it had failed. Figure 6 shows the tops and bottoms of the original and replacement drums and demonstrates the poor condition of the original with multiple cracks. Most telling is the side view of the original showing stripped splines that were destroyed by the harder brass dial cog. Only the top half of the dial drum cog engages with the dial pointer cog so the bottom half of the cog remained in pristine condition. The drum was cast as a single unit so there is no way to bring the intact teeth from the bottom to the top. The old unit was shown the bin.

The string tensioning is not done with a spiral spring, but with a torsion spring wire. The result is two hooks projecting from the drum that are bent back when the string is tensioned. The reassembled dial worked as expected.

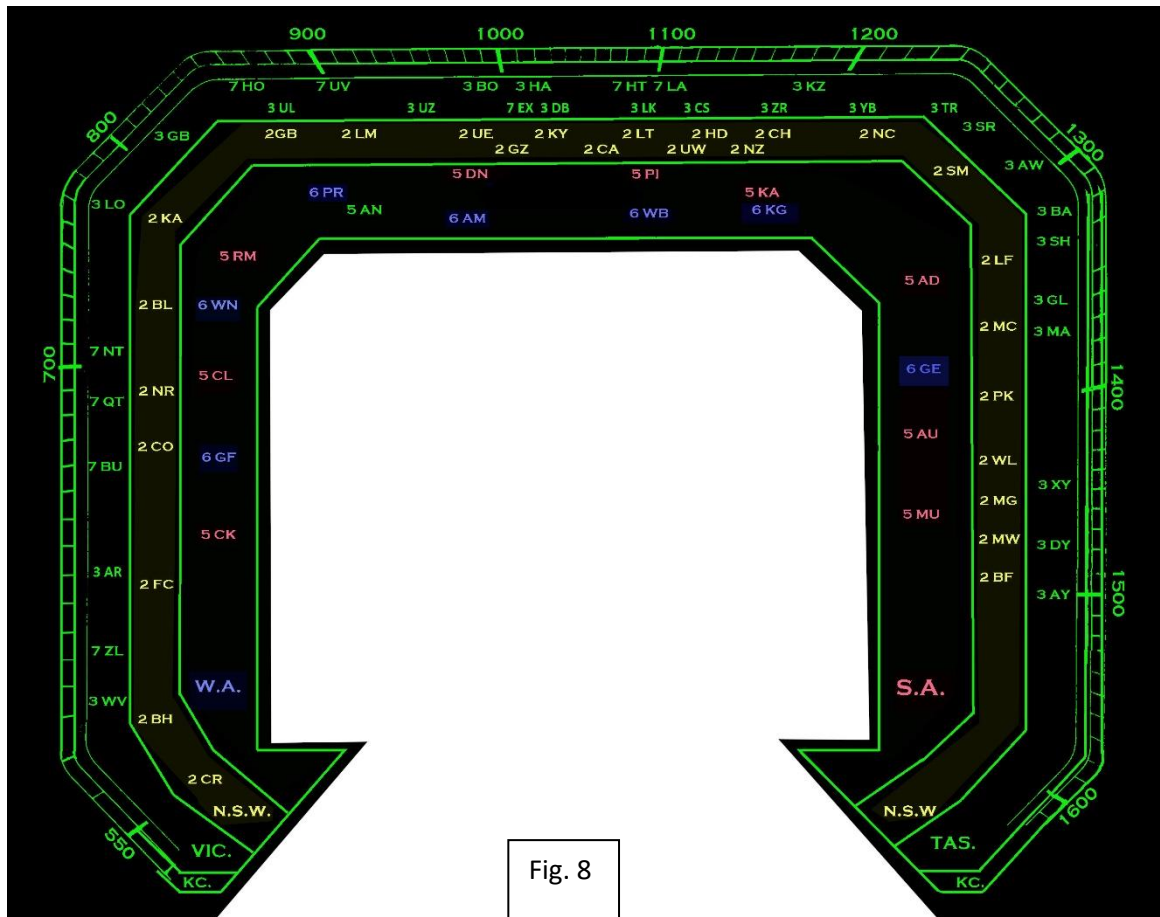
Fig. 8

of being edited to an acceptable standard. Covid lockdown thrust upon me the luxury of time to create new artwork that replicated the station information. The new artwork was jointly created between PowerPoint (to type in station call signs) and the GIMP image editing software. The final result (figure 8) was printed onto glossy photo paper. The centre section was cut out to reveal the shortwave information. This printed sheet was placed directly over the shortwave glass to be sandwiched by the next layer.

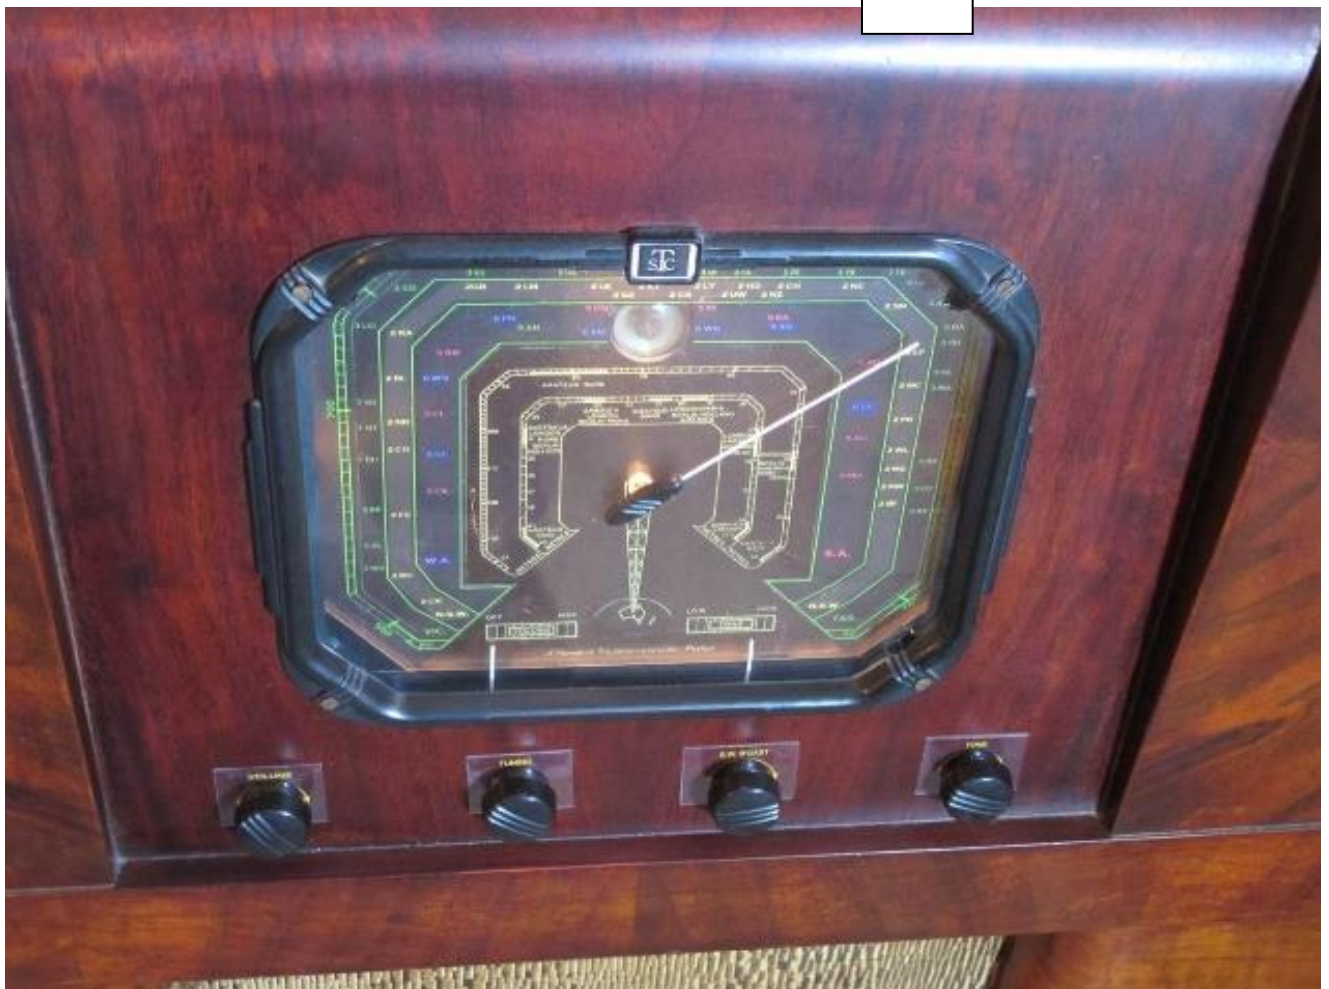
Fig. 9

One more touch was available for this restoration. Carl Taller had given me some plastic screen-printed sheets to label volume, tone, tuning and wave change. You may find Carl a useful contact for reproductions of commonly needed, but hard to get badges and art work (see advert on inside back cover of this issue). And in the end, my favourite console radio was complete and functional. It had left the queue of radios waiting for me to get back to someday.
