Democrat 1948 console

By Graham Parslow

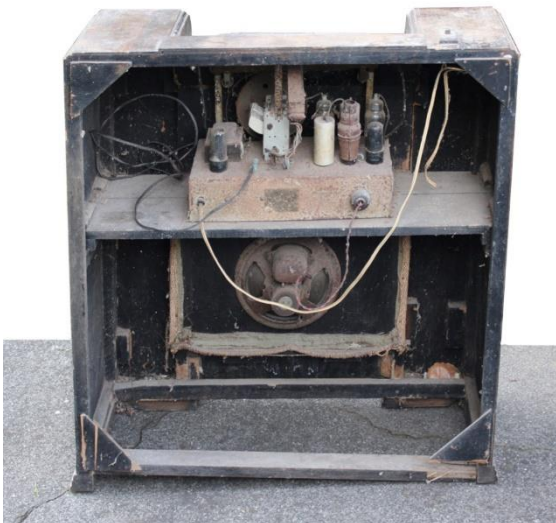
Everything was seriously dirty and corroded. I was only going to find the motivation to continue if the chassis was made to look respectable. This required removing the valves, abrading the metal surfaces then painting. Abrading involved a metal scraper and Flexovit P240 cloth-backed wet and dry paper. The almost-indestructible cloth-backing lasts far longer than conventional wet and dry paper. When this paper clogs with rust it can be restored by washing with water.

The main chassis was painted with Brunswick green, the dial backing plate with mission brown, the magic eye supporting bracket with black and the Goat shield and dial side-plates with chrome. A reproduction ARTS&P label was attached to the rear of the chassis. It had then begun to look like a tidy unit.

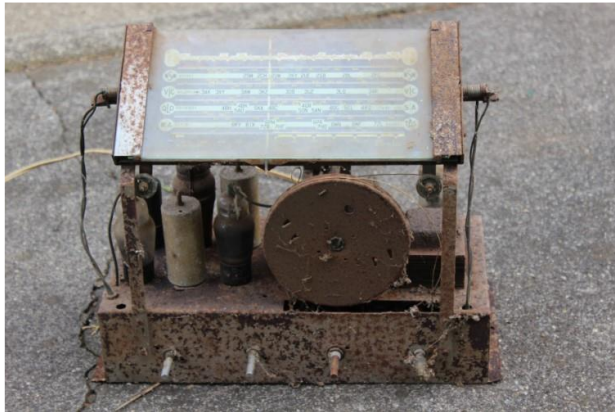
The front of the chassis was degraded by a broken dial string and rusty dial drum. By good luck I had an identical dial drum on my salvage shelf and the original went to the bin. Fortunately, the glass dial was in good condition.

It took a while to work out a functional stringing of the dial and what I came up with was unlikely to have been the original stringing. After getting it working I needed to

increase the spring tension for reliable operation and that pulled the string over a ragged edge that cut the line. With file in hand that edge disappeared and the second stringing was far more quickly achieved. The Bakelite knobs were ultrasonically cleaned and it was time to start the electrical restoration.

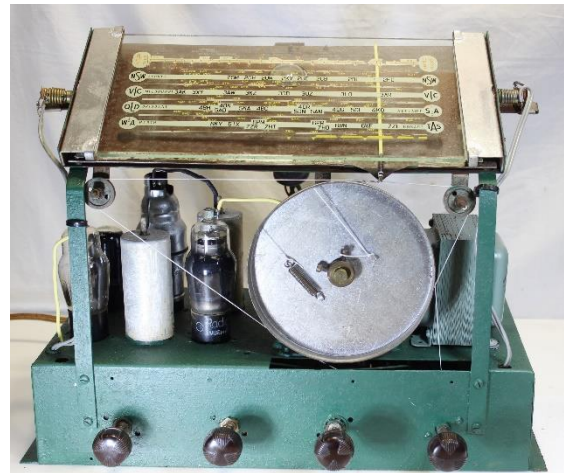
The first assessment was a check of the transformer with no valves in place. The result was puzzling. What was certain was that the original transformer was headed for the bin. The 5V and 6.3V windings were fine, but the HT secondaries were producing 140V at both sides of the centre tap (far too low). The

transformer was also consuming 120W although there was no arcing or dreaded smoke. I have no explanation for this because I would expect shorted turns to affect one side of the secondary HT windings relative to the centre tap (not an even 140V each side as measured). By good luck I had a suitable replacement transformer on my salvage shelf.

The replacement transformer was larger, mounted vertically and required some metal work to install. The bonus was that the replacement was a better quality unit than the one it replaced. The original had the transformer wires terminated on a phenolic board immediately under the transformer body. This board was left in place and the flying leads from the replacement transformer were soldered to the appropriate lugs on the board.

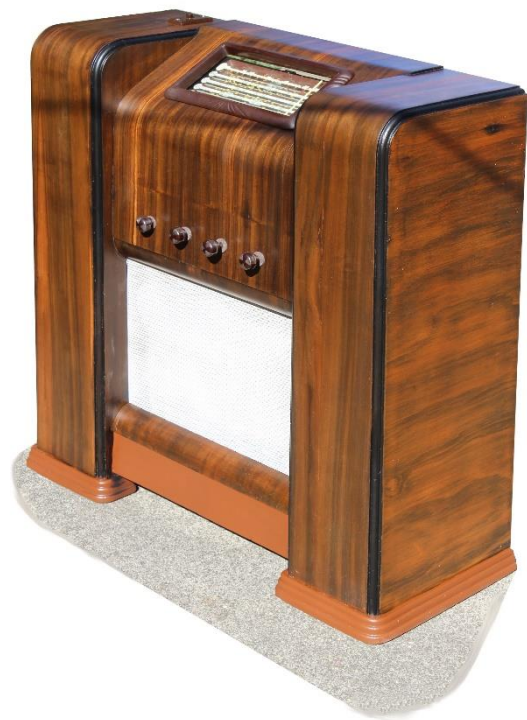
The frame of the 8 inch Rola speaker was severely corroded. However, that was not the major reason that led to it being binned. The cone was poling, that is the voice coil was rubbing against the coil gap. Because no 8-inch was in my stock I replaced it with a 6-inch

Rola speaker complete with transformer from my salvage shelf. A new baffle board was cut to size and new speaker grille cloth installed at the front of the baffle.
