Pye 9MSW 1955

By Graham Parslow

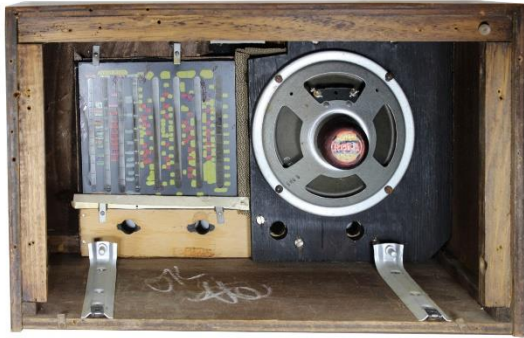
The photo of the empty rear shows how two metal mounting-strips lock the chassis by pins at the front and screws at the back.
